# BACHMAN LAKE DAM REHAB PROJECT

Water Facilities Project Management &  
Stormwater Operations Dallas Water Utilities

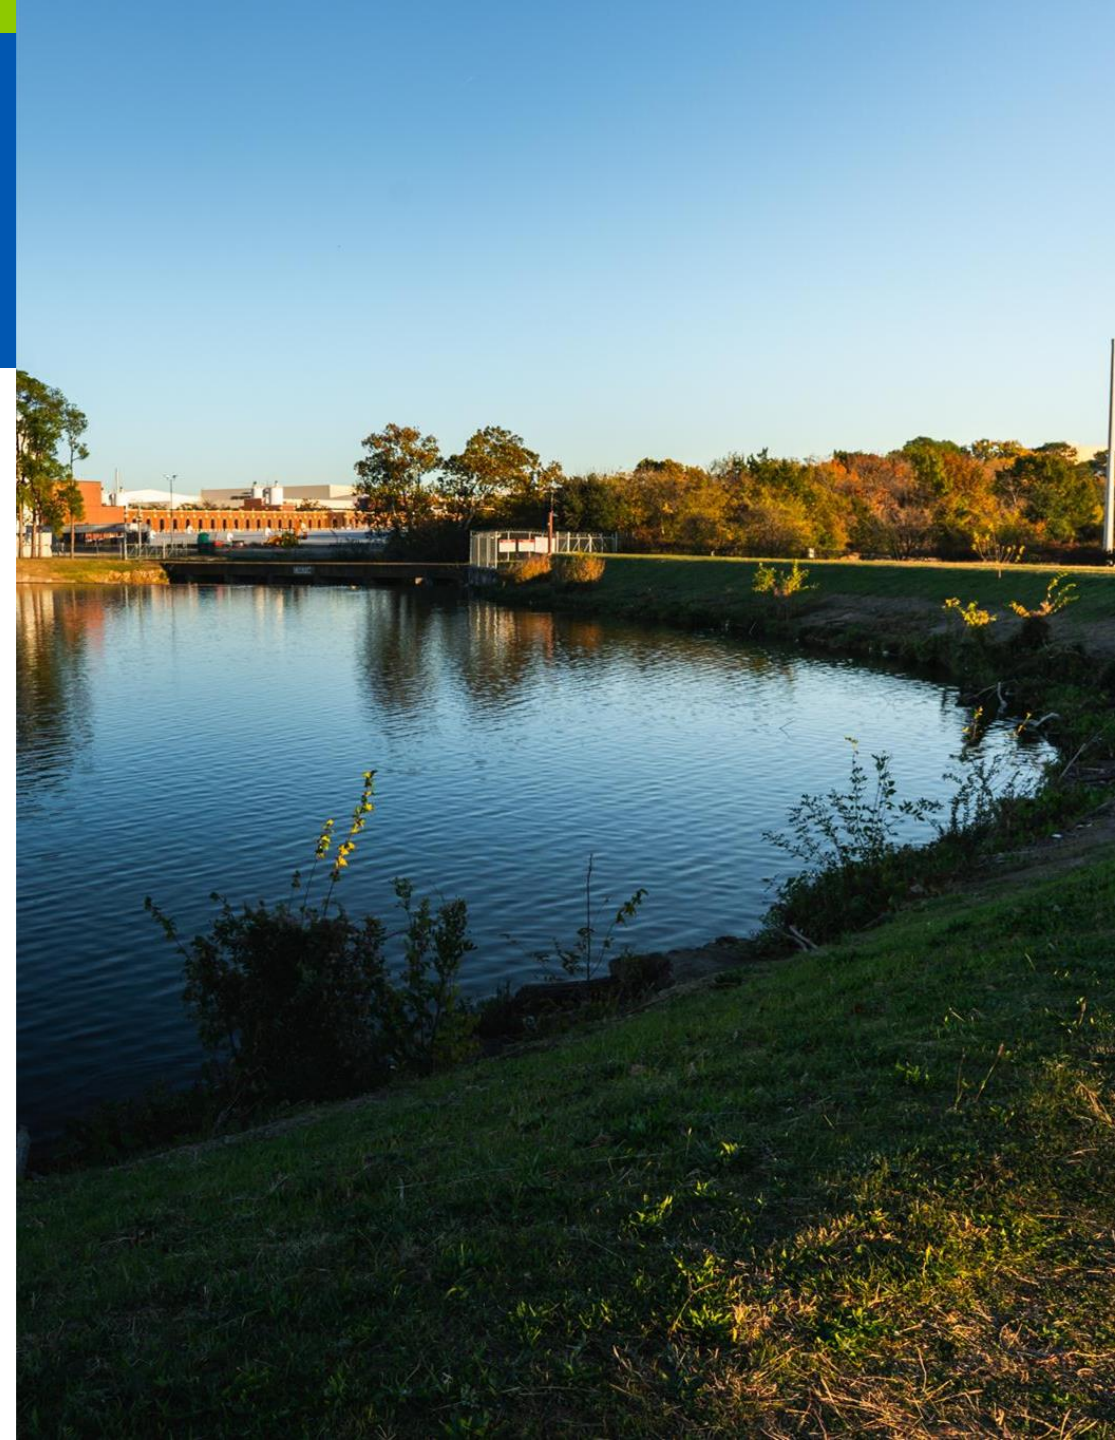
- Dam was built in 1901
- Originally used for water supply
- Converted to recreational use in 1960s
- 35' tall earthen embankment
- 180 foot long concrete overflow spillway

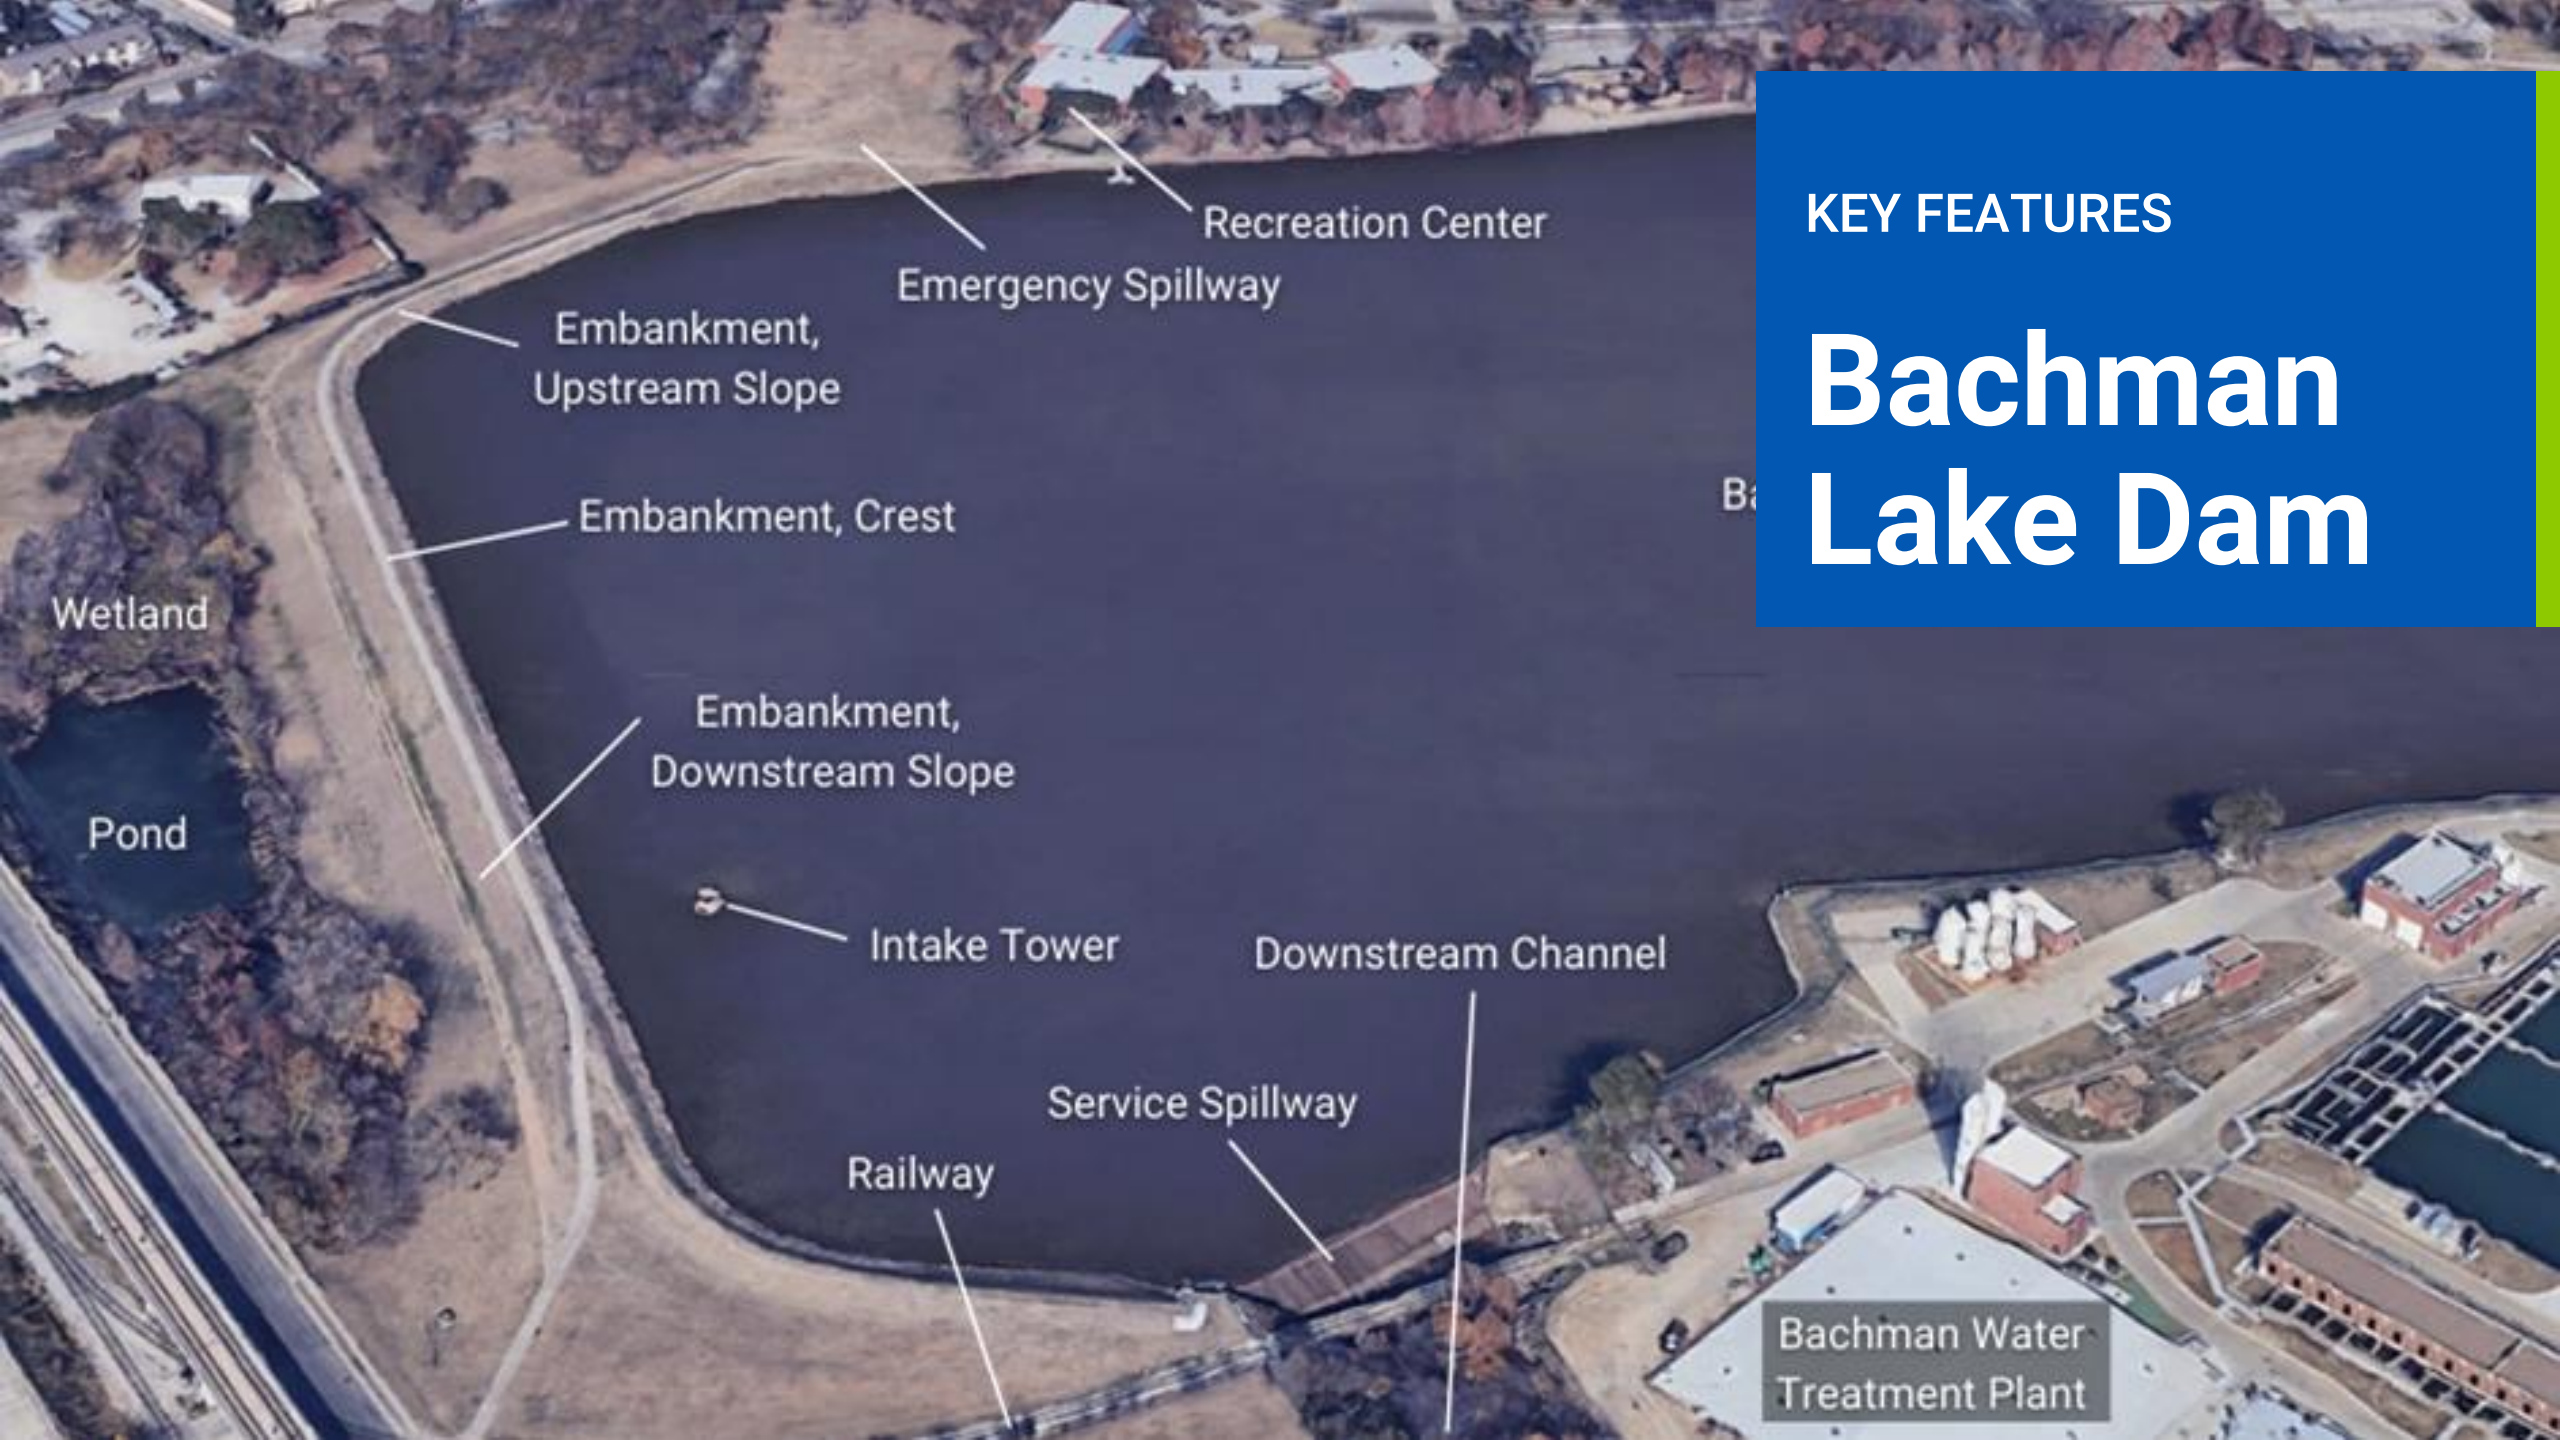
# Bachman Lake Dam

KEY FEATURES

Recreation Center

Emergency Spillway

Embankment,  
Upstream Slope

Embankment, Crest

Wetland

Pond

Embankment,  
Downstream Slope

Intake Tower

Downstream Channel

Service Spillway

Railway

Bachman Water  
Treatment Plant

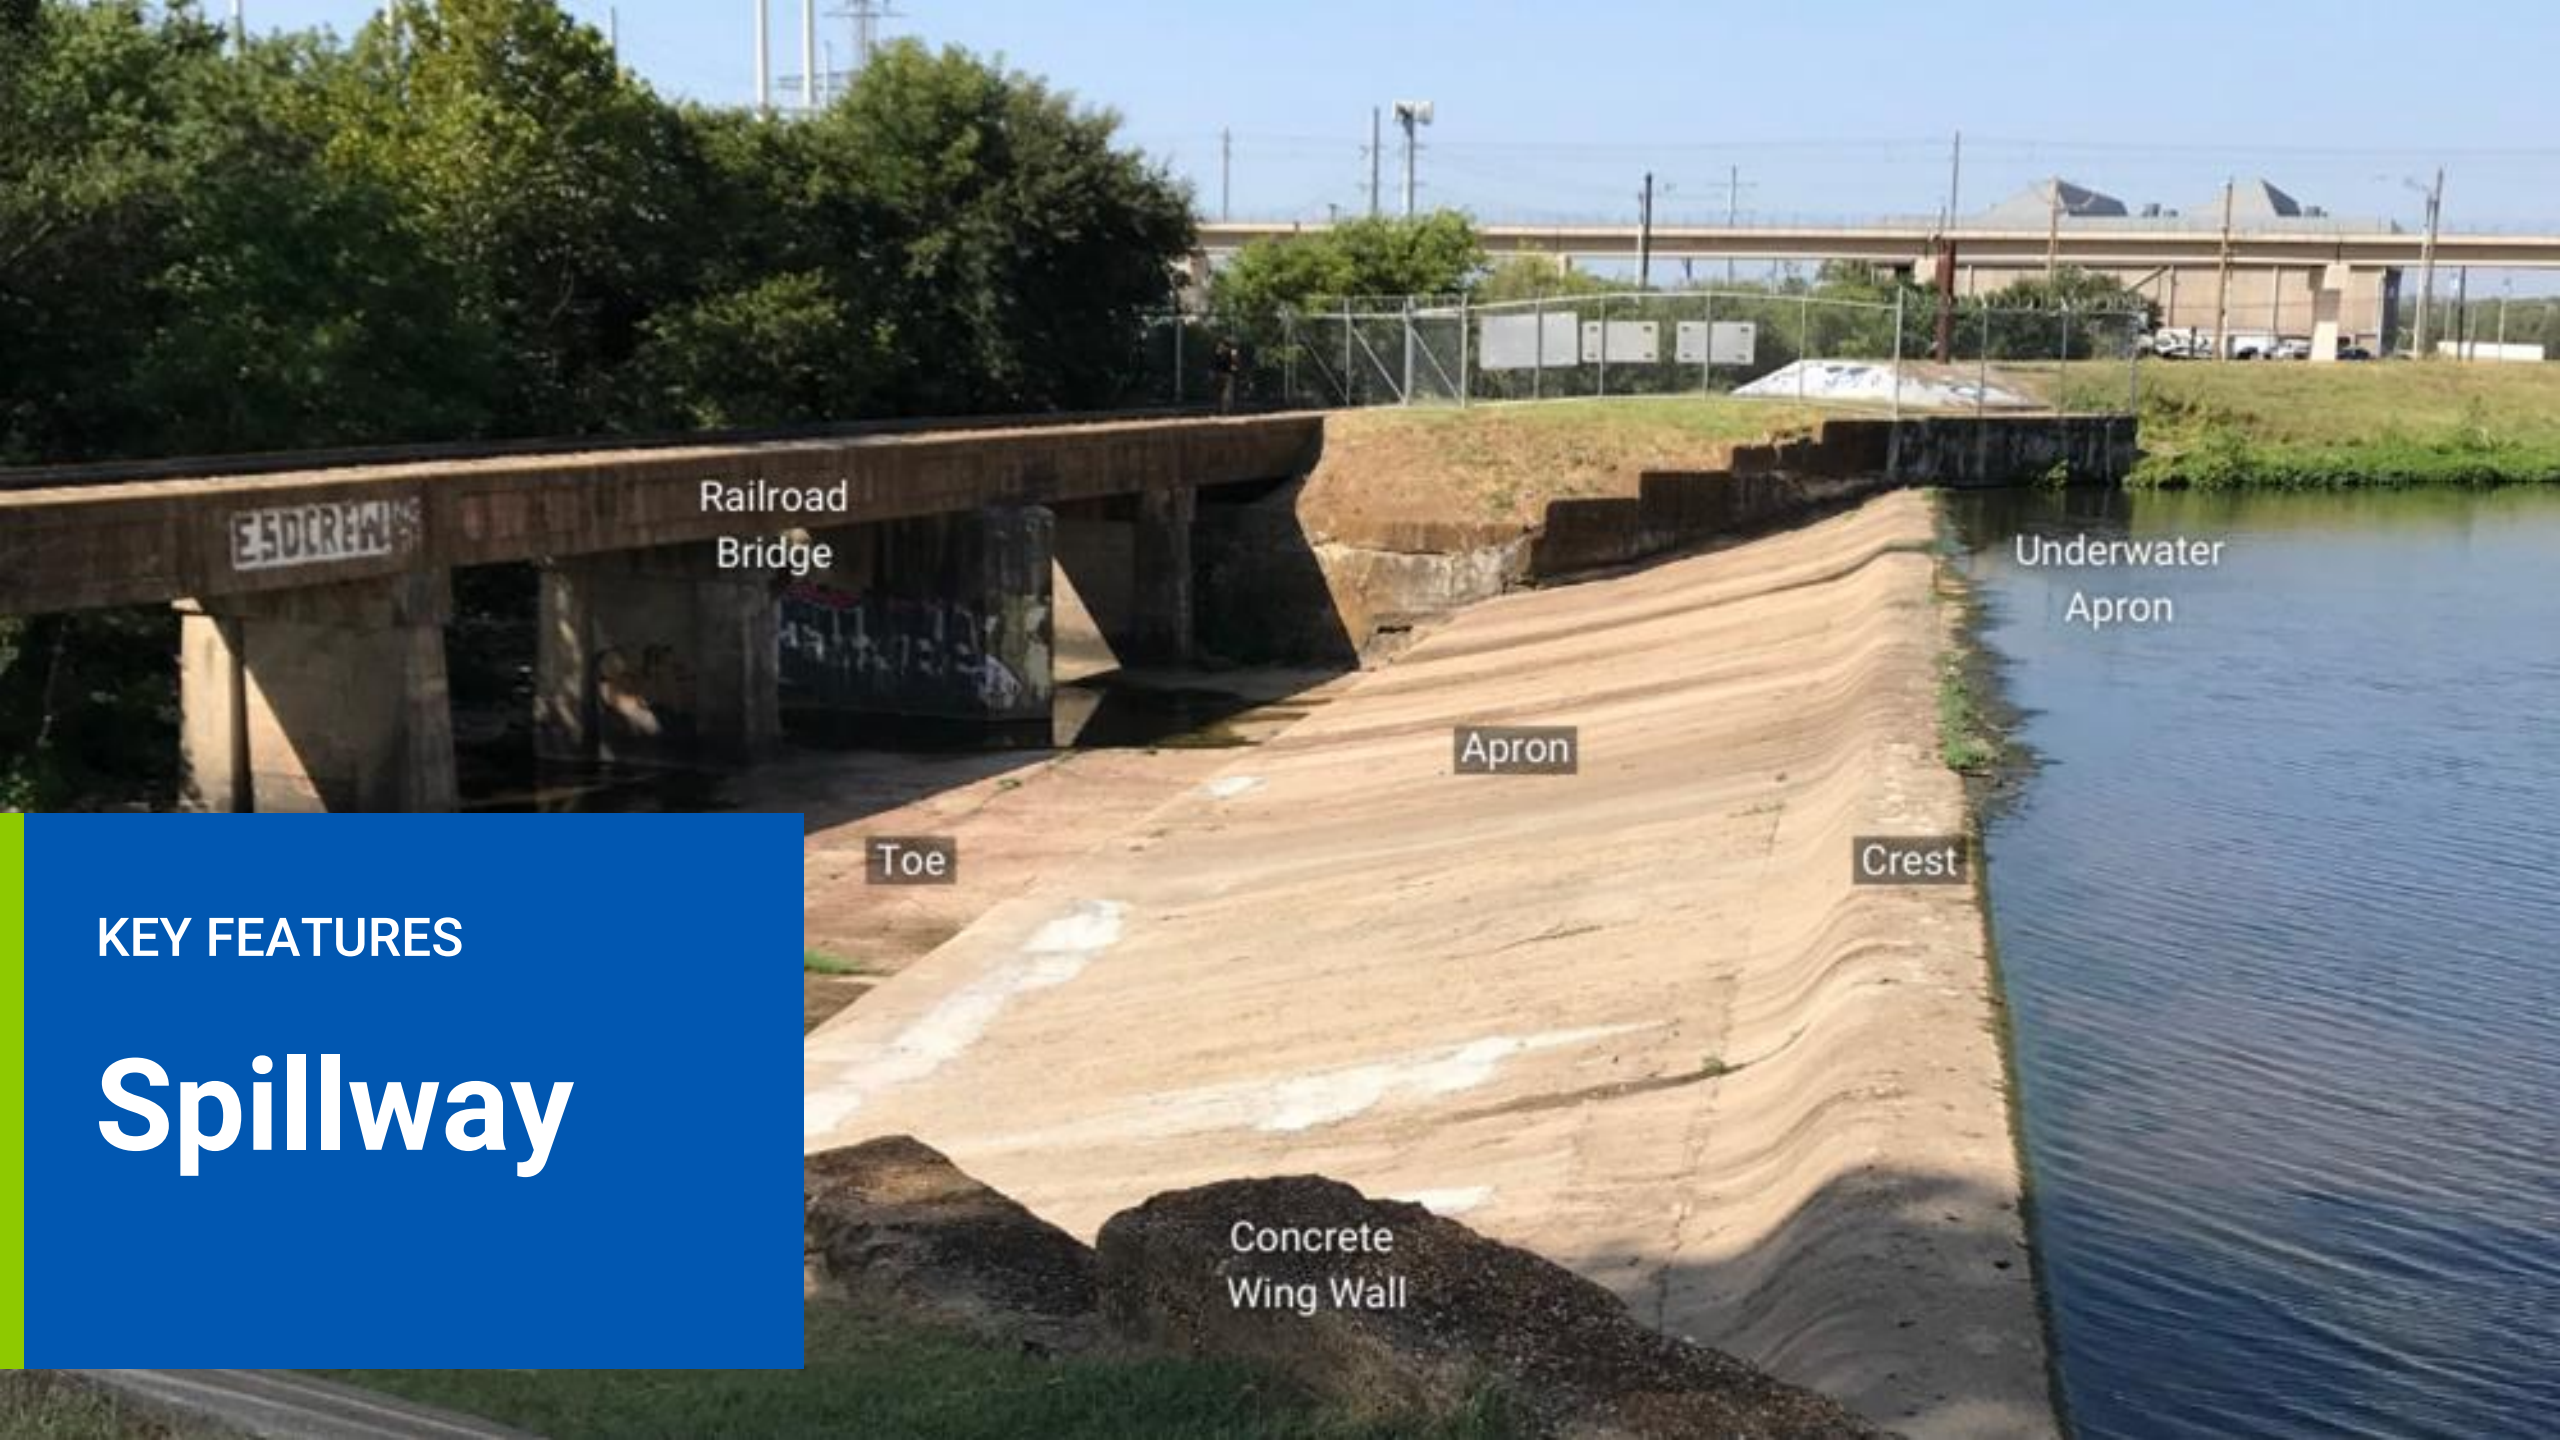
# Spillway

Railroad  
Bridge

Underwater  
Apron

Apron

Toe

Crest

Concrete  
Wing Wall

KEY FEATURES

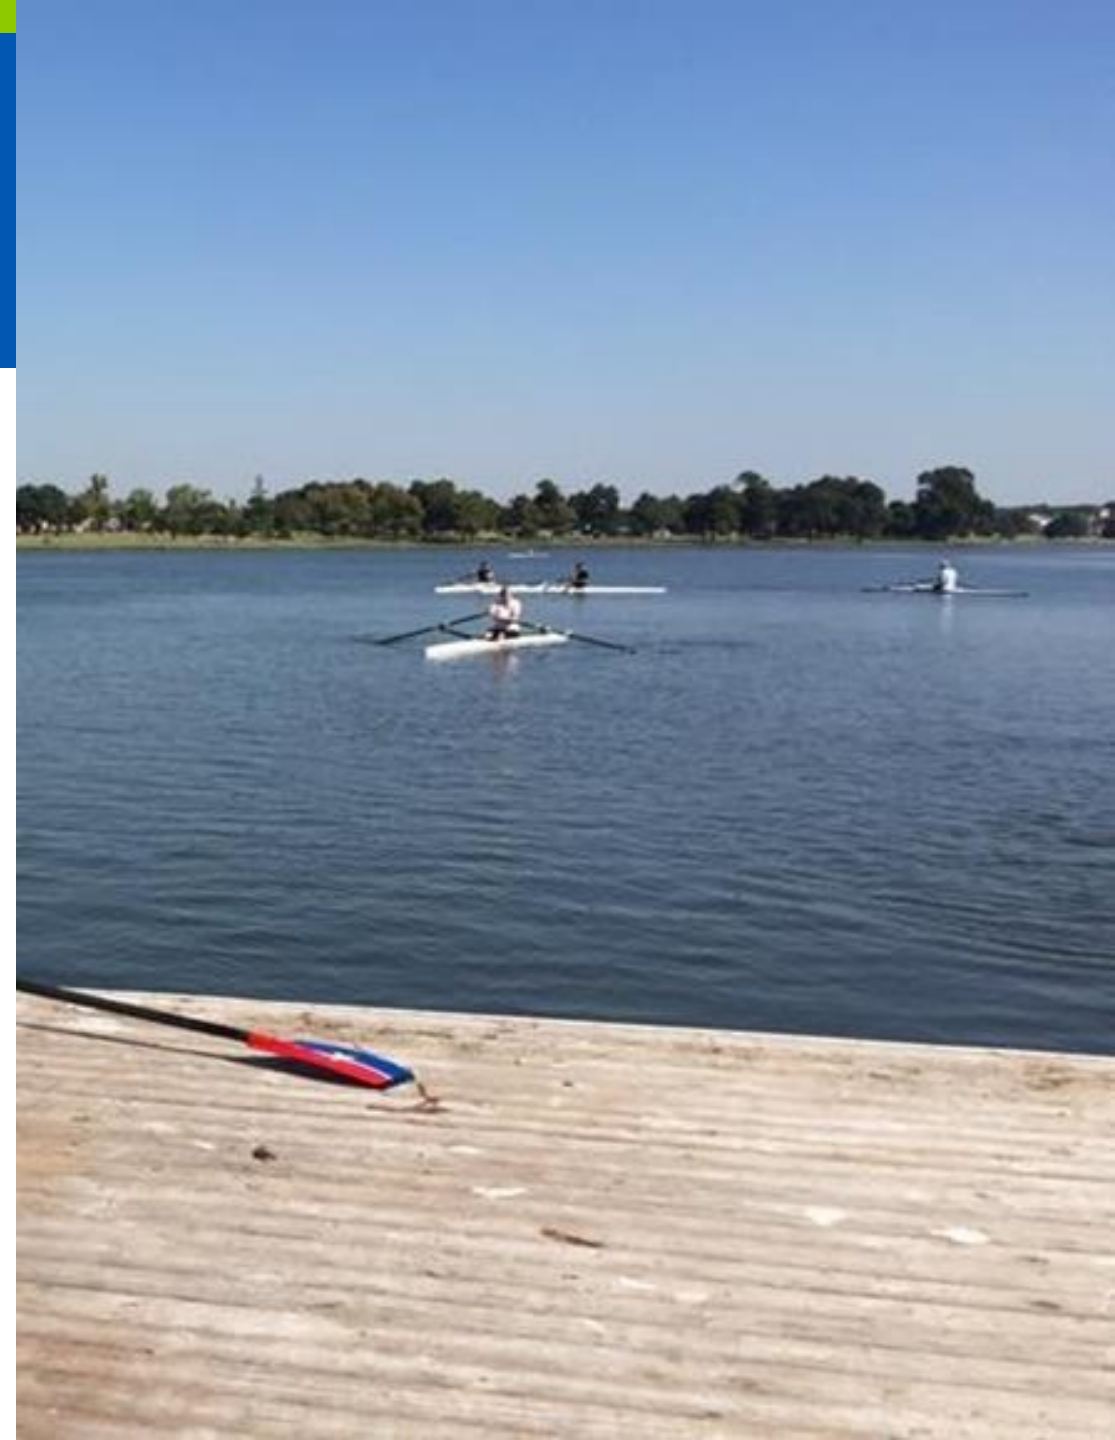
- Excessive debris buildup from sedimentation can reduce lake depths
- High sediment levels affect recreational activities and reduce reservoir capacity
- Shallow water depth can lead to invasive aquatic vegetation problems

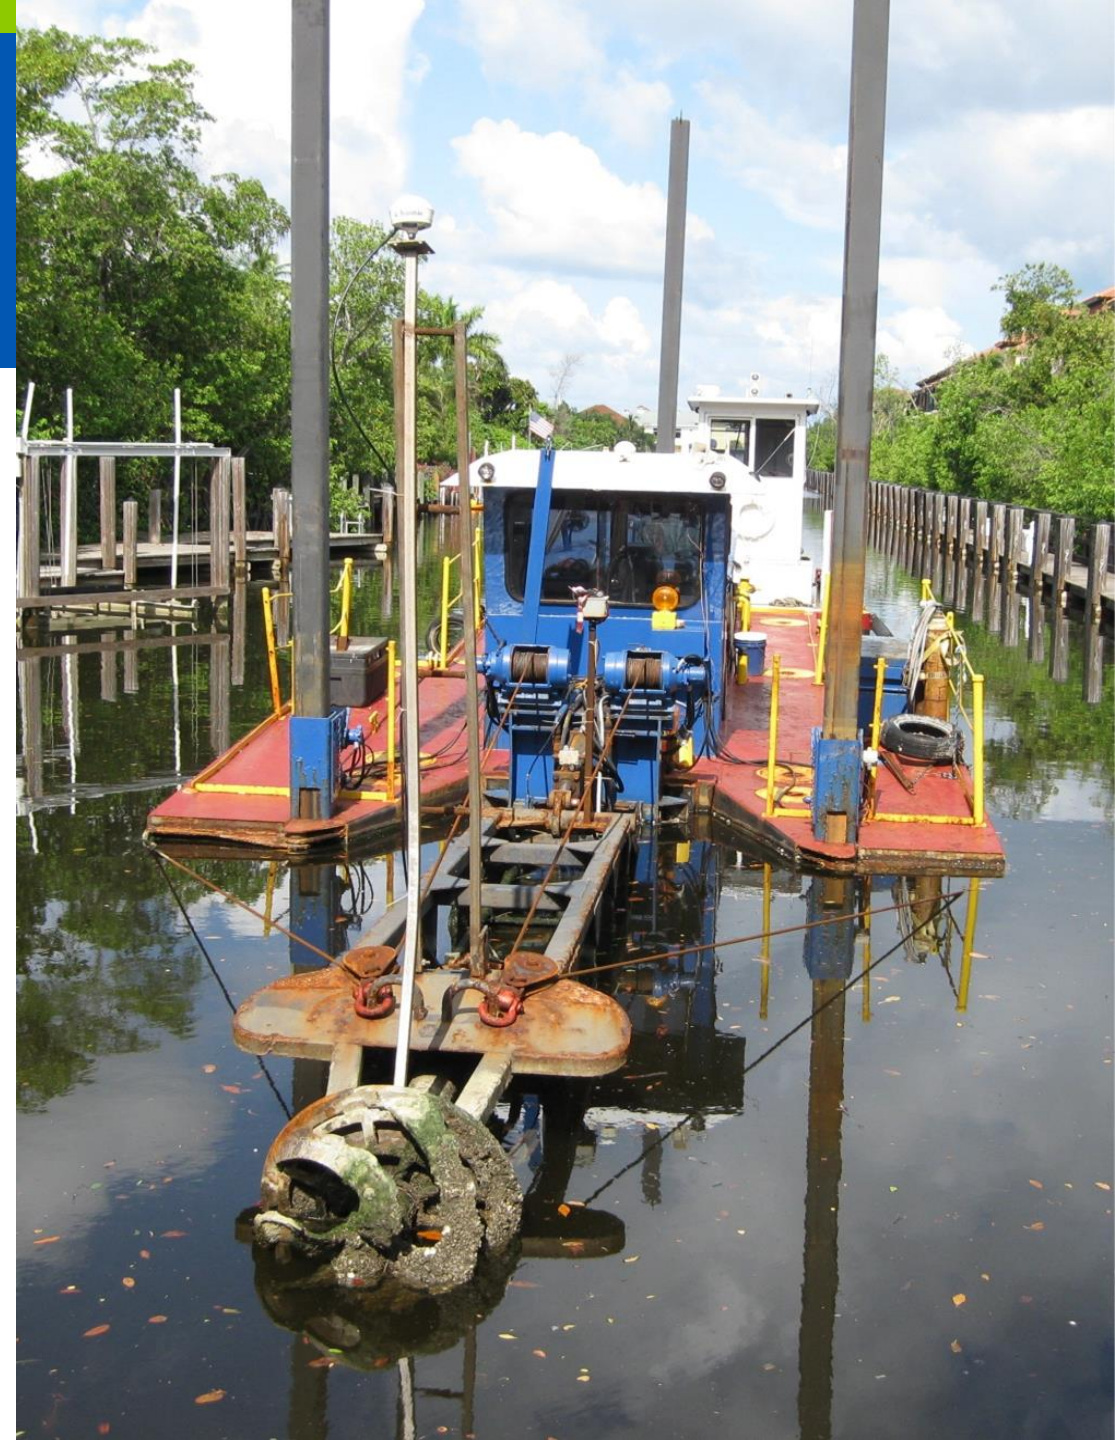
- Removal of accumulated debris from the bottom of the lake via mechanical equipment

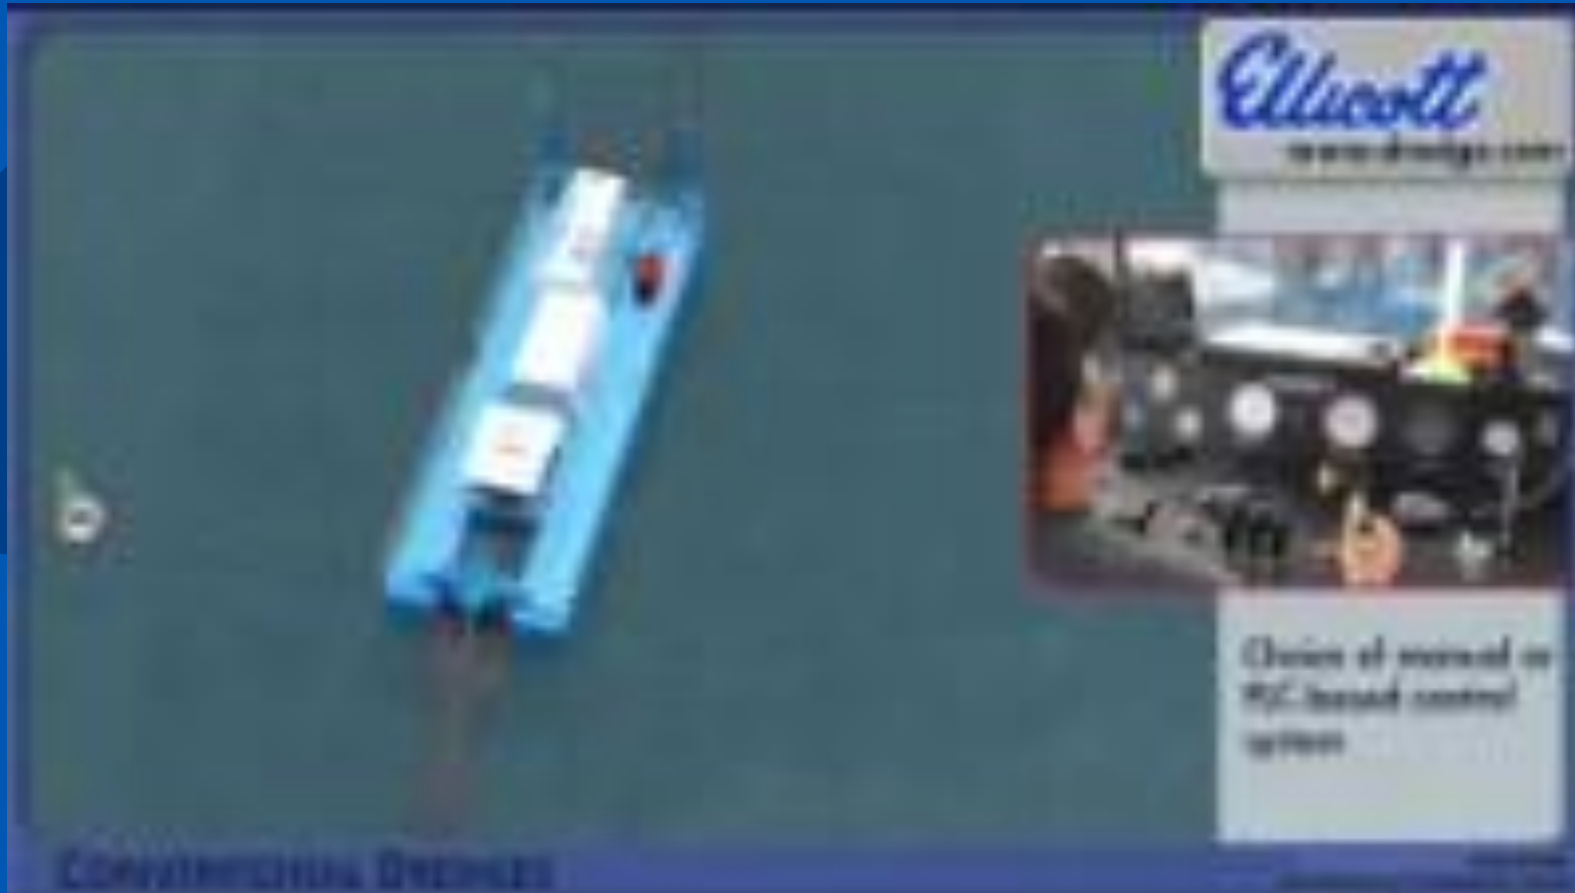
## CUTTERHEAD DREDGE ANIMATION

# DREDGING IN MOTION

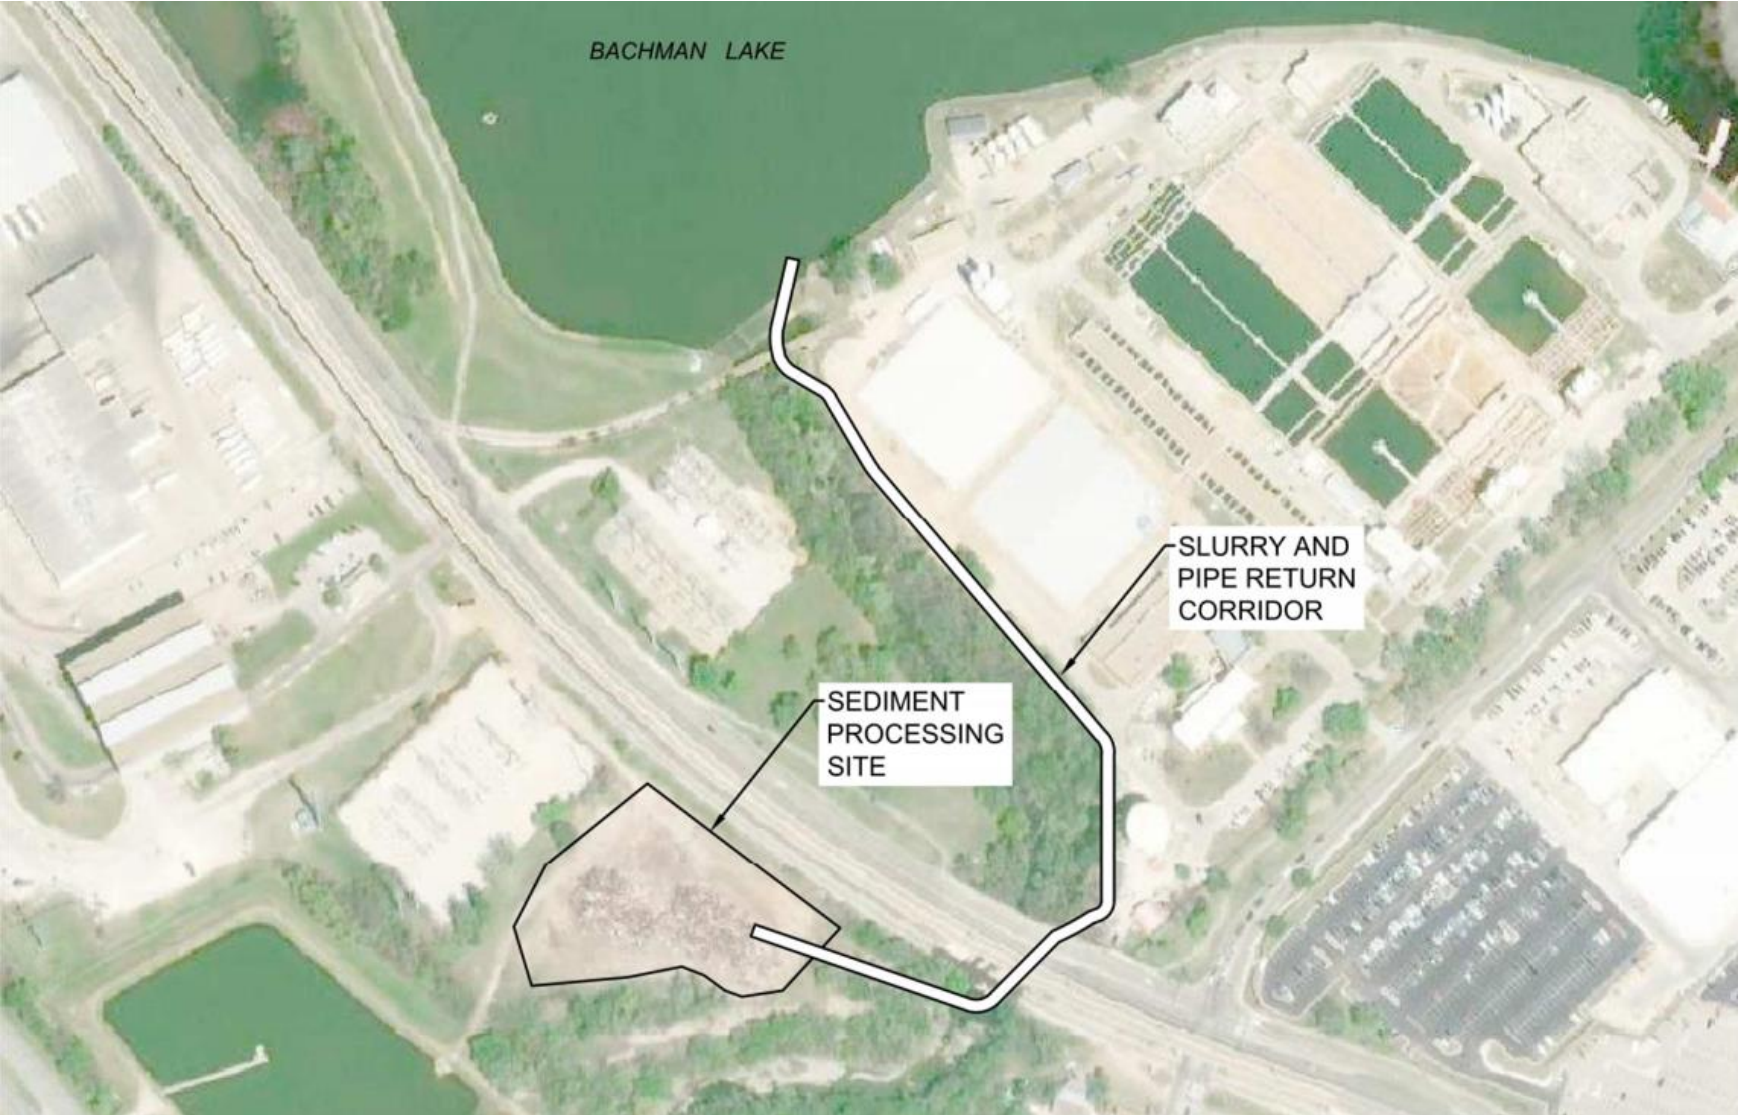
# PROPOSED PROCESSING SITE

- Loosened material removed by dredging equipment will be transported for dewatering
- Dredged material from Bachman Lake to be transported to the offsite dewatering area

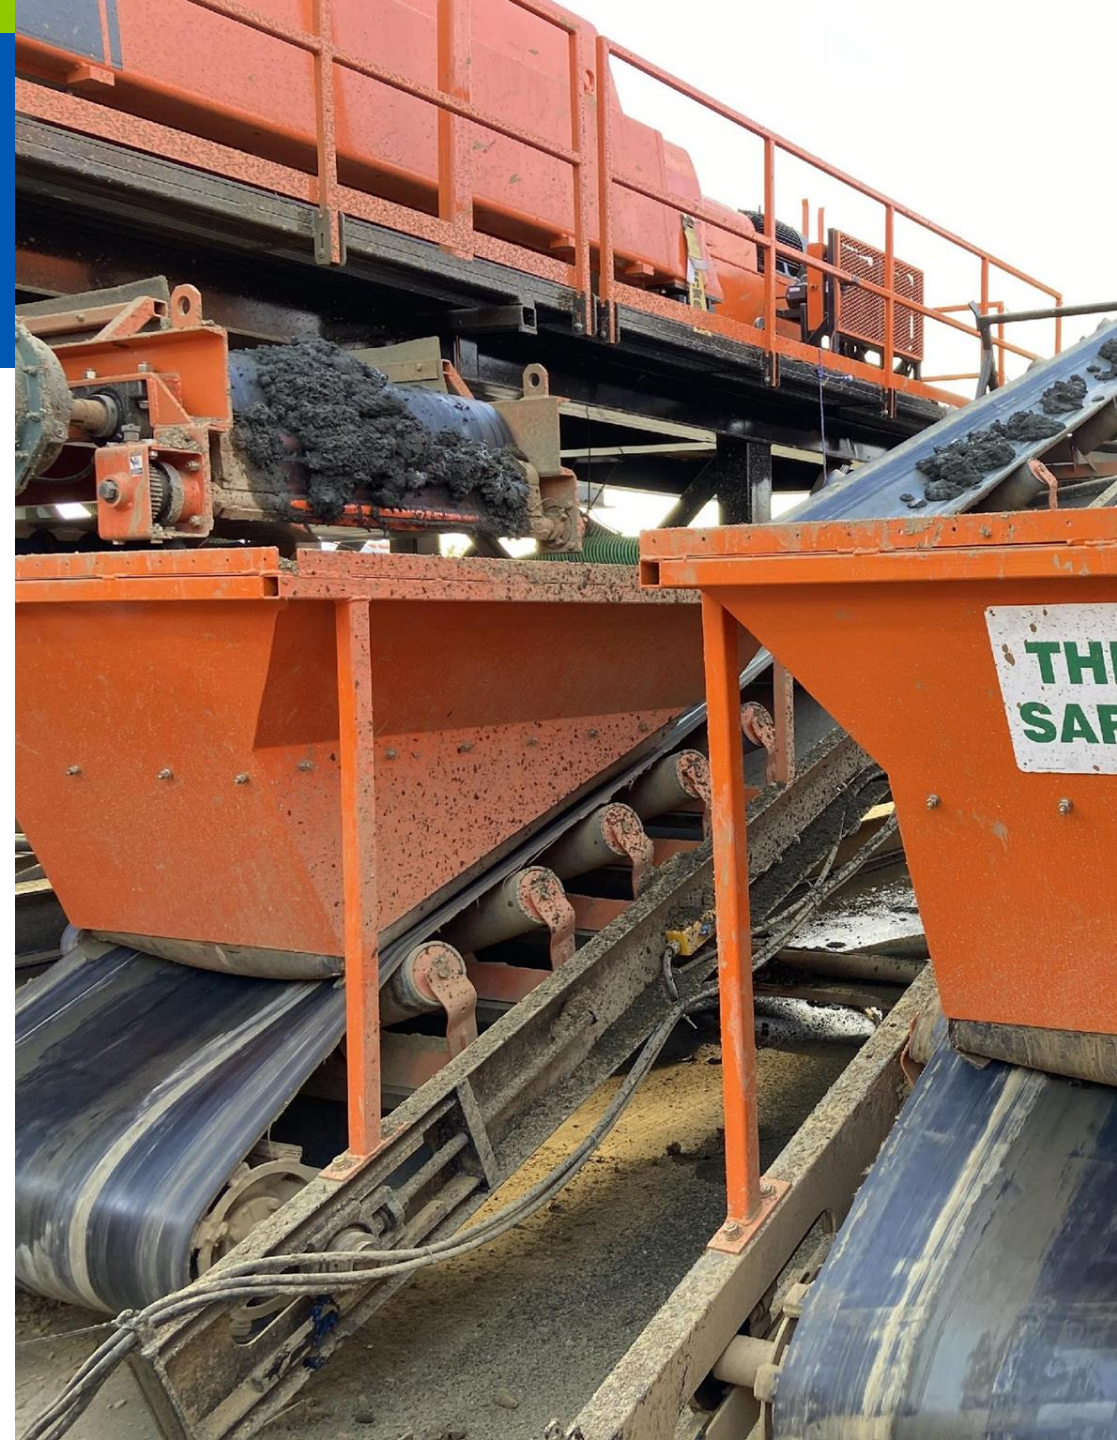
- Removal of water from dredged sediment and other solid material
- Why? For ease of transport of dredged material and save hauling costs
- Excavated material will be trucked to a landfill for daily cover

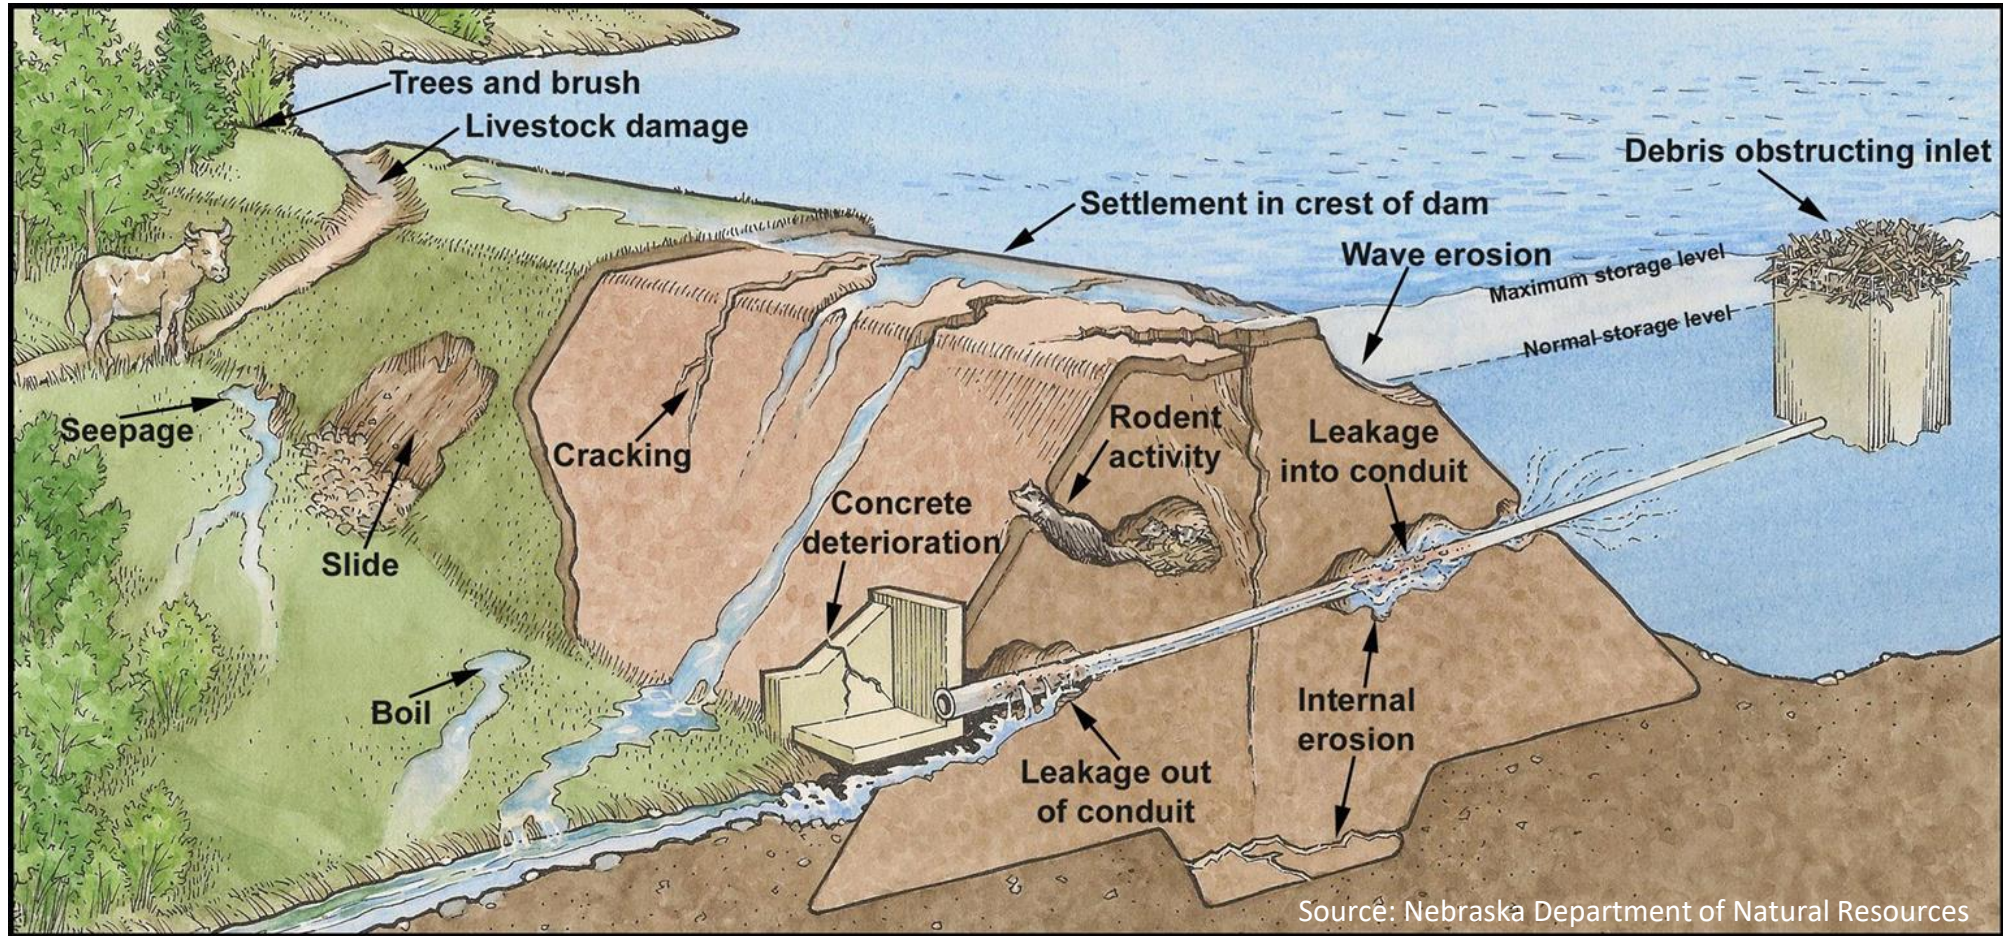
# COMMON DAM ISSUES

- Preserve dam integrity
- Maintenance of embankment & spillway
  - Trees / underbrush
  - Erosion
  - Seepage
- Protects downstream property and infrastructure

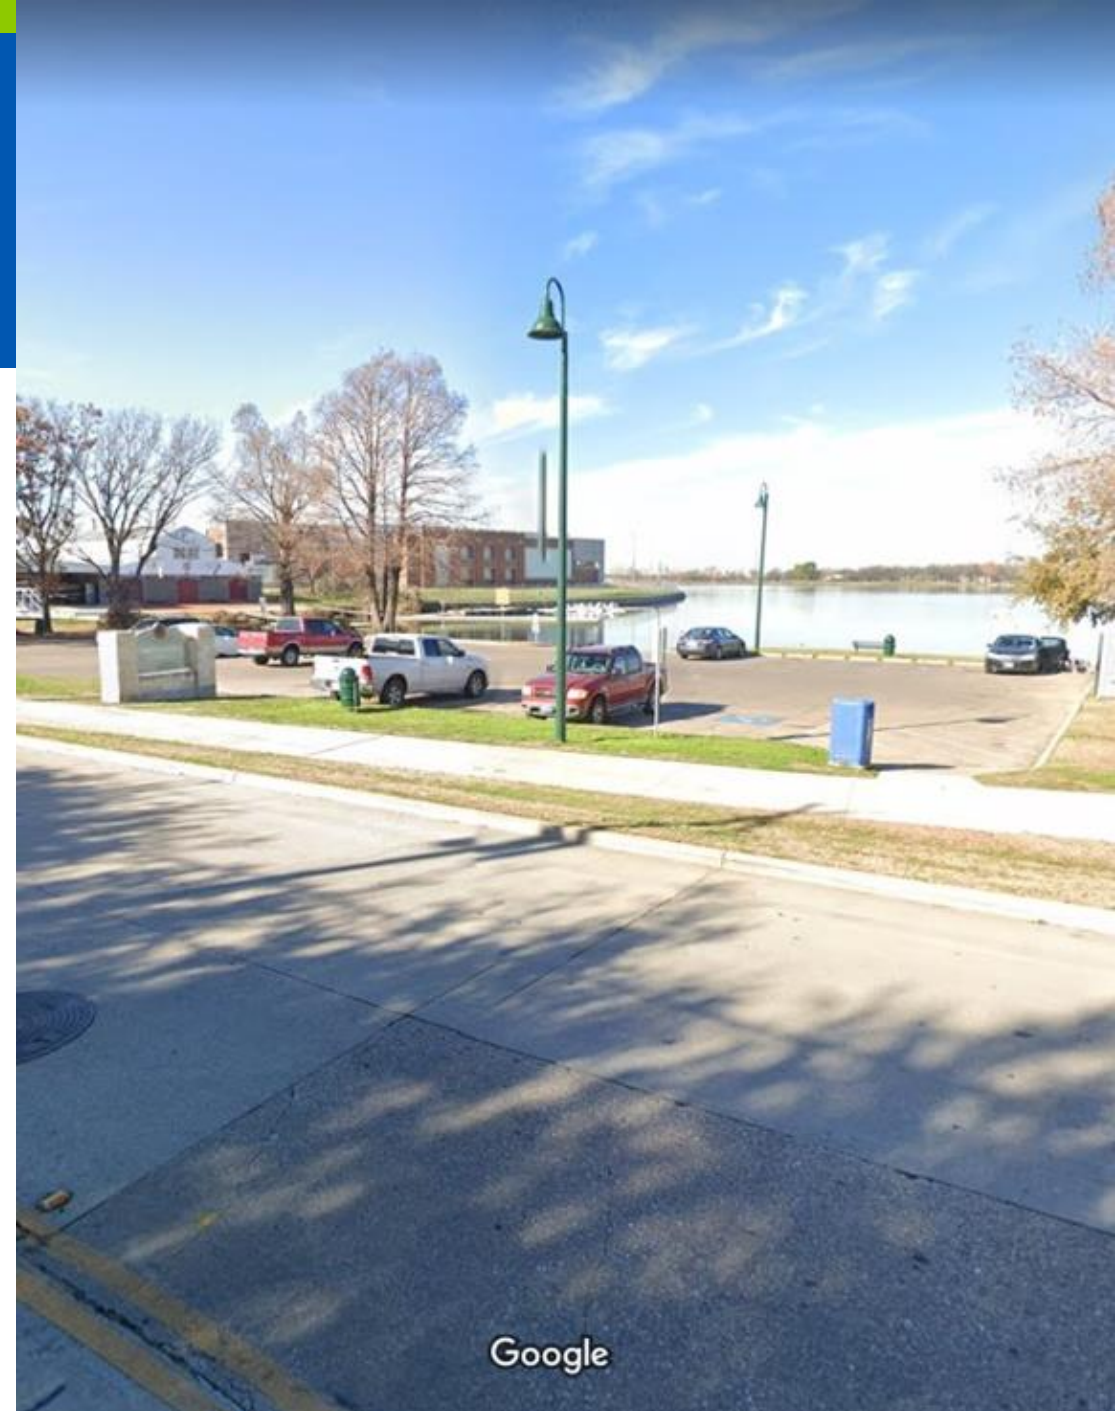
- 60% design completion, Construction Fall 2021
- South Parking Lot by Rowing Club
  - Deployment of dredging barge
  - Daily transportation of employees to barge
  - Assembly of dredge slurry pipe
  - Parking lot closed during project
  - Rowing/boating limited due to floating slurry pipe

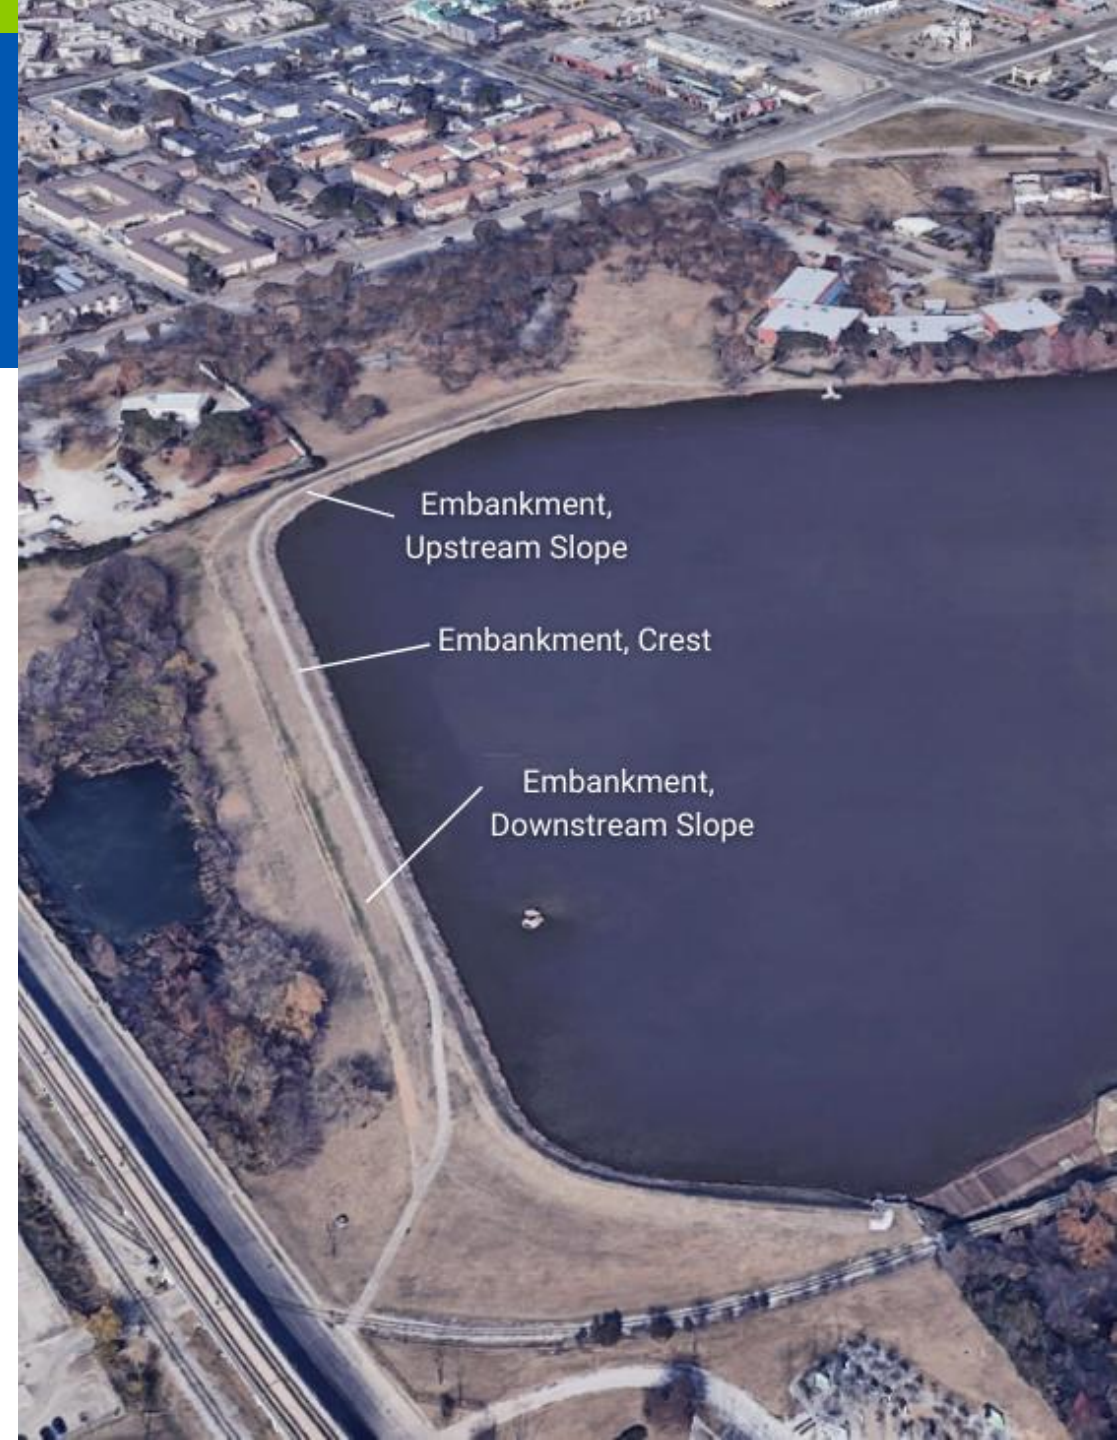
- Preliminary H&H completed
- Strengthen and stabilize embankment
- Currently evaluating regulatory requirements
