# BACHMAN LAKE DAM REHAB PROJECT

Water Facilities Project Management &  
Stormwater Operations Dallas Water Utilities

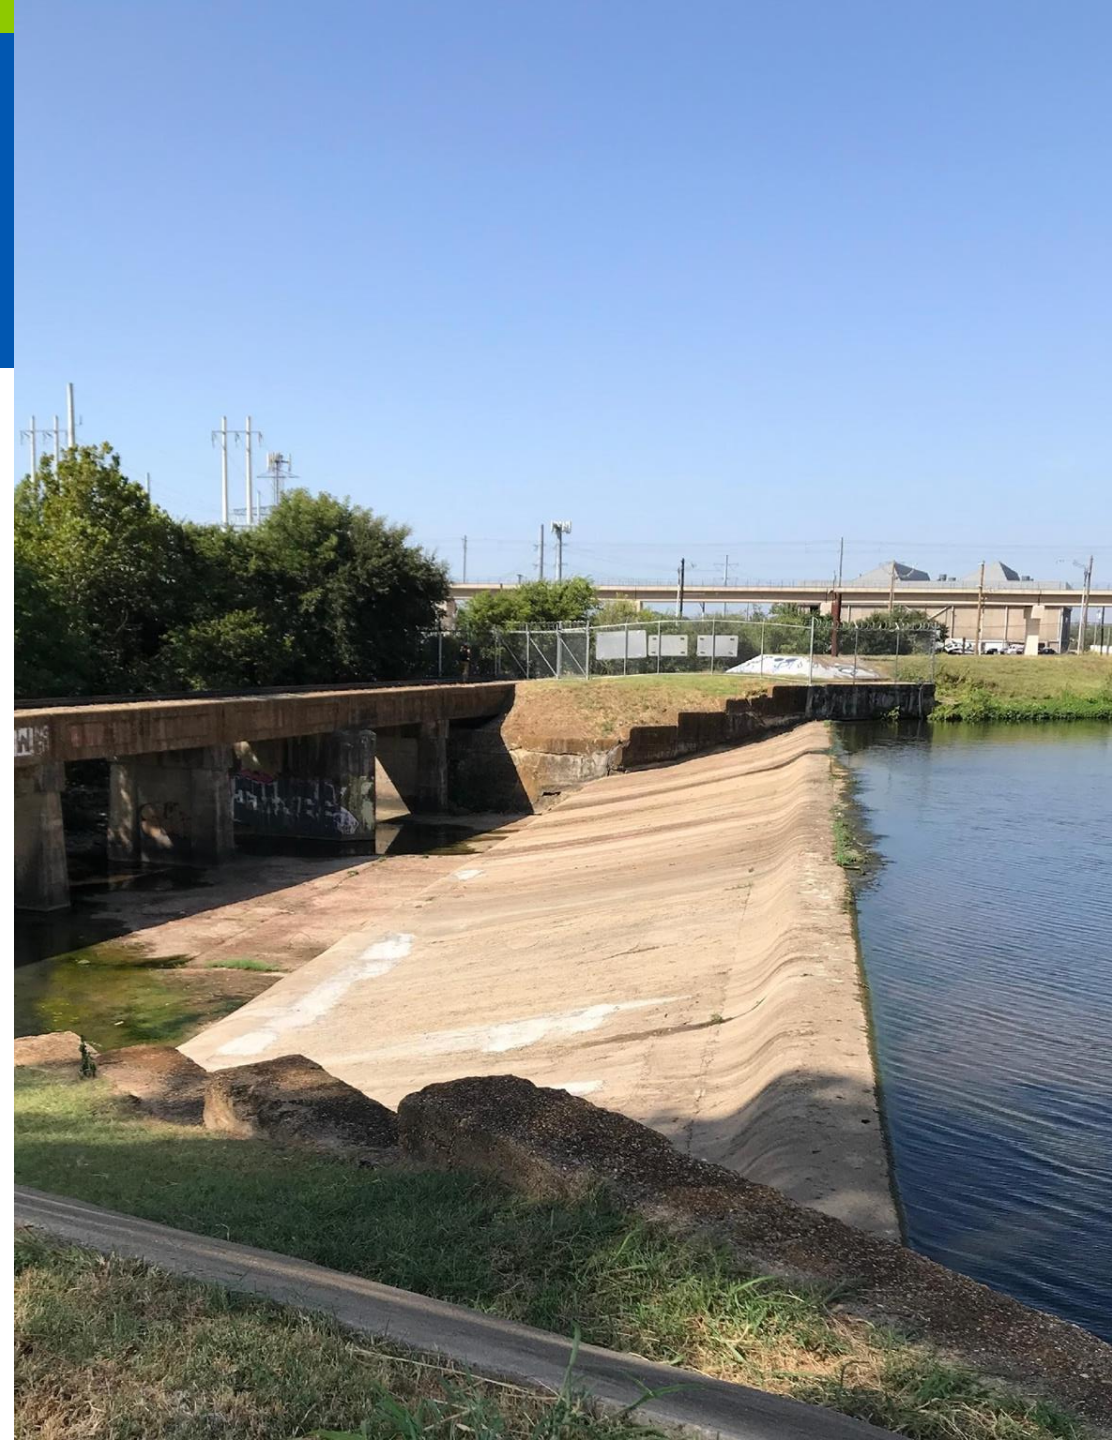
- Service Spillway to be replaced
- Currently evaluating design options and regulatory requirements

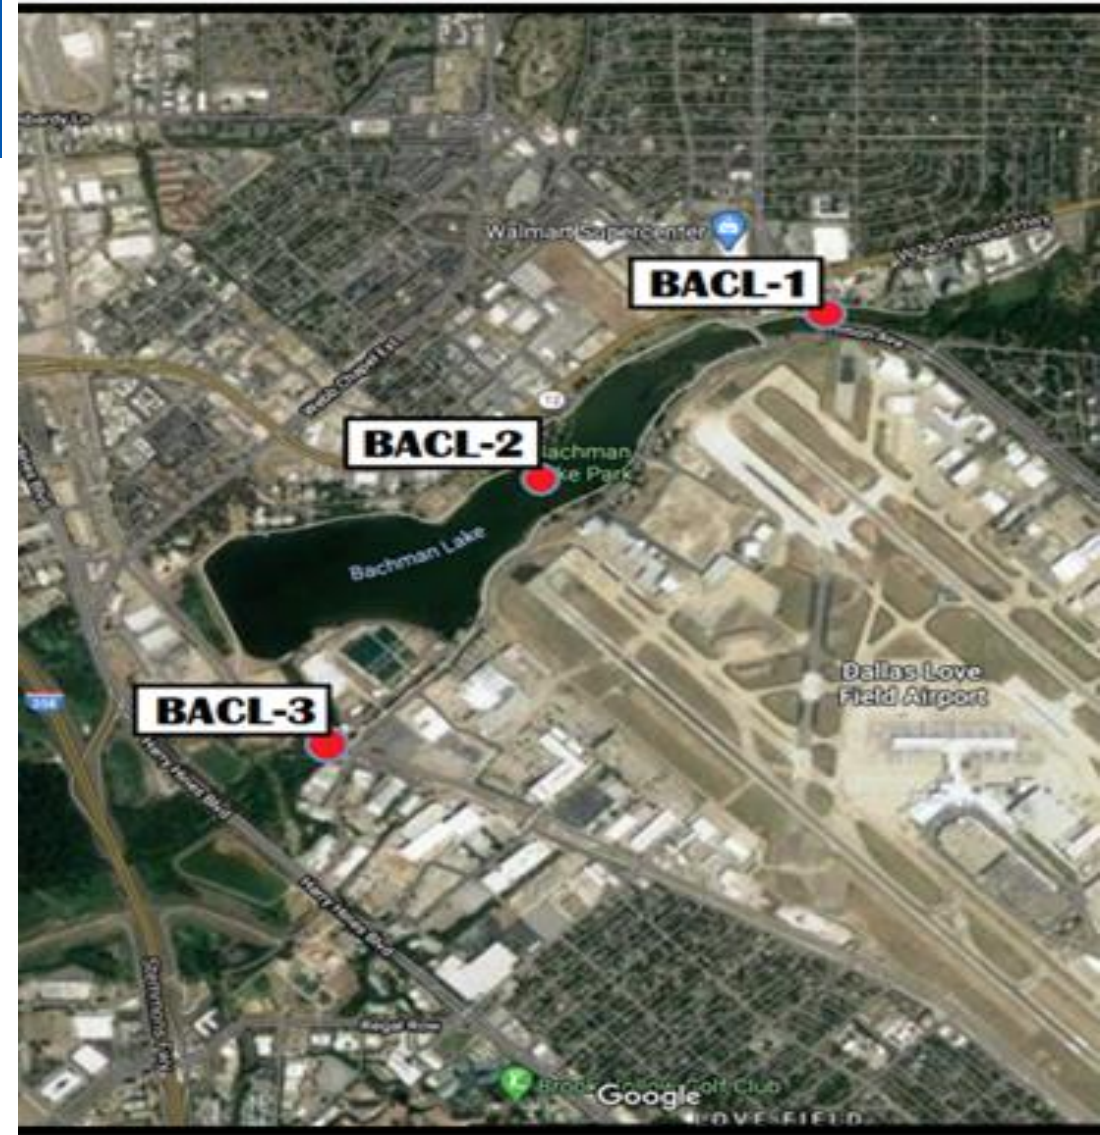
# Sampling Locations

- From January to June of 2020, samples were collected from three sites (BACL1, BACL2 & BACL3) located on the lake.
- Water Quality was compliant with Texas Surface Water Quality Standards during the first event of sampling. From July 2020 samples are collected from upstream and downstream sites only.

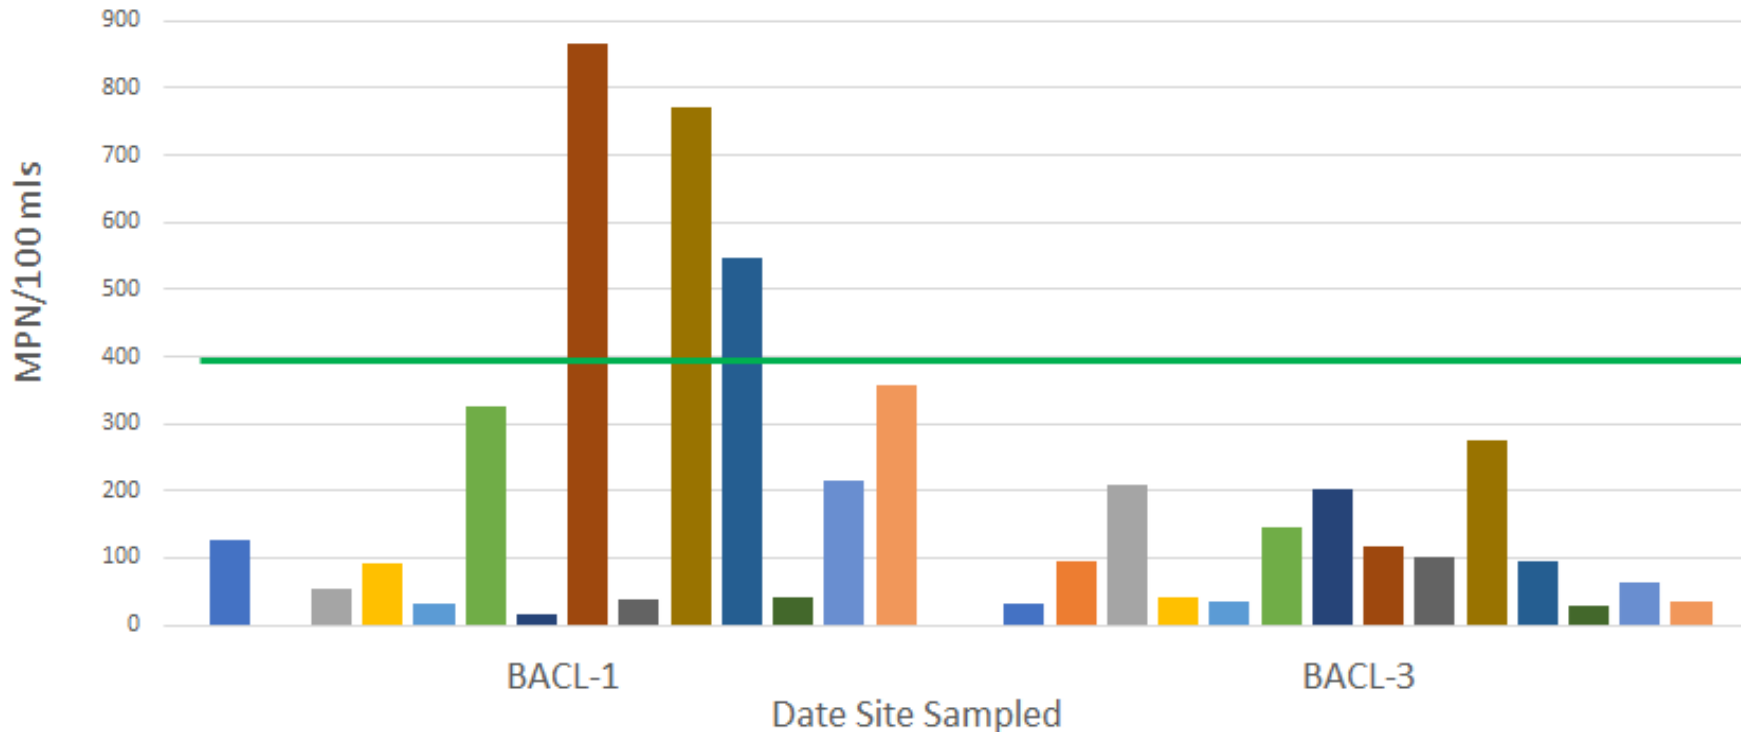
E. coli Results

Collection Date	BACL-1	BACL-3
1/7/2020	125.9	30.9
2/4/2020	>2419.6	95.9
2/7/2020	54.8	209.8
3/3/2020	90.9	42.6
4/7/2020	32.3	36.4
5/5/2020	325.5	143.9
6/2/2020	17.3	201.4
7/7/2020	866.4	116.9
8/4/2020	38.4	101.7
9/1/2020	770.1	275.5
9/8/2020	547.5	95.9
10/6/2020	42	29.2
11/3/2020	214.1	61.7
12/2/2020	357.8	35.3

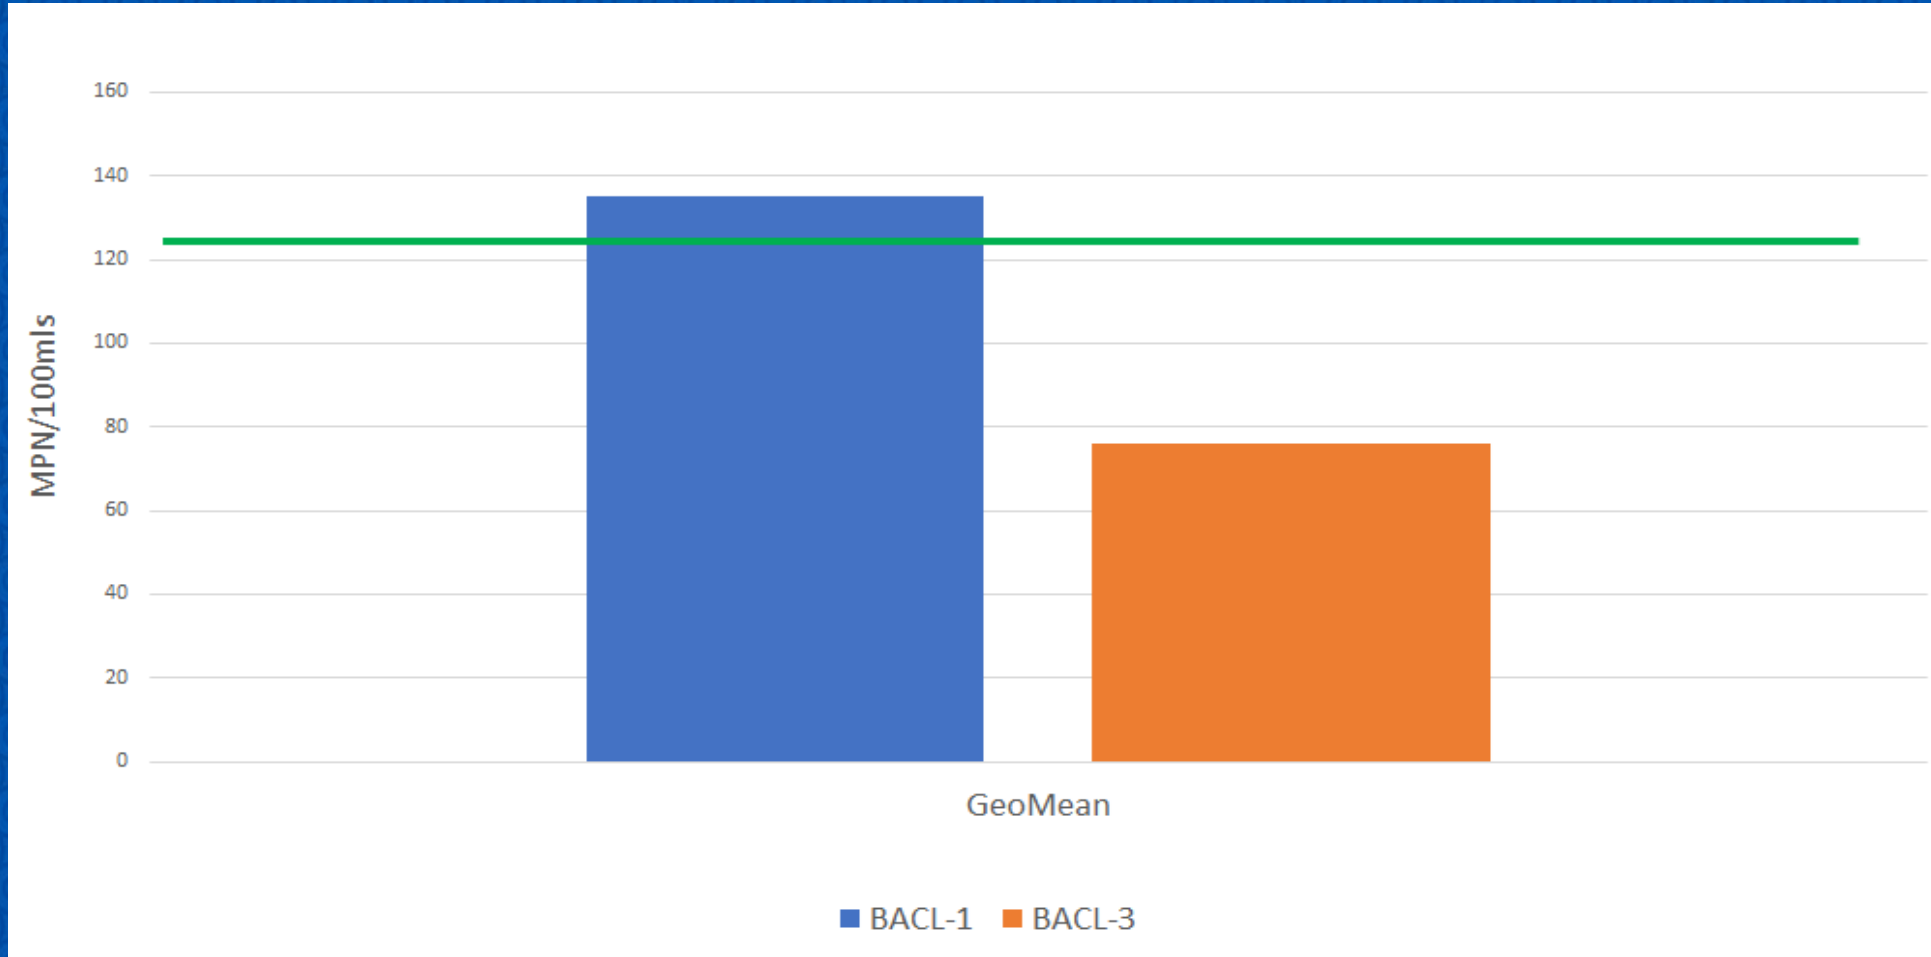
# SITE GEOMEANS

Site ID	GeoMean
BACL-1	135
BACL-3	76

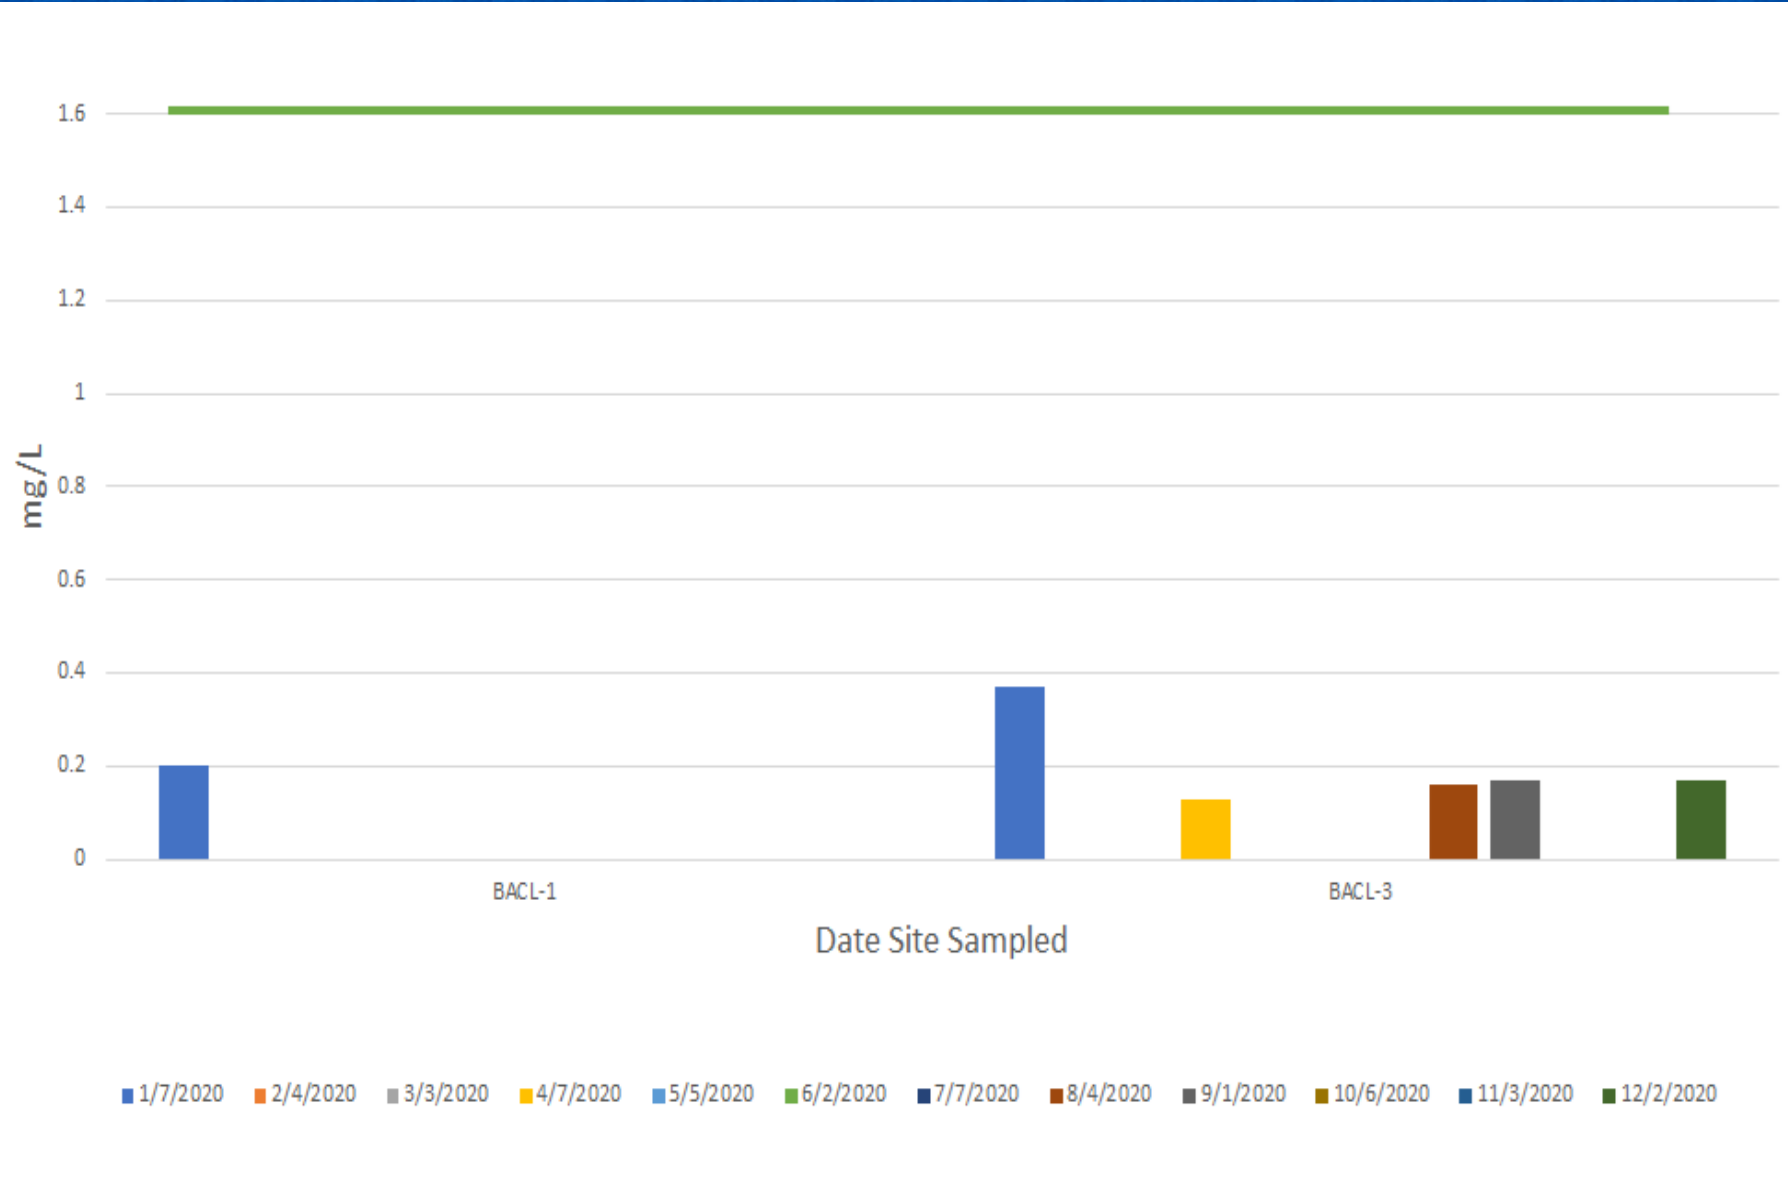
# MONTHLY AMMONIA RESULTS

Collection Date	BACL-1	BACL-3
1/7/2020	0.2	0.37
2/4/2020	0	ND
3/3/2020	0	ND
4/7/2020	0	0.13
5/5/2020	0	ND
6/2/2020	0	ND
7/7/2020	ND	ND
8/4/2020	ND	0.16
9/1/2020	ND	0.17
10/6/2020	ND	ND
11/3/2020	ND	ND
12/2/2020	ND	0.17

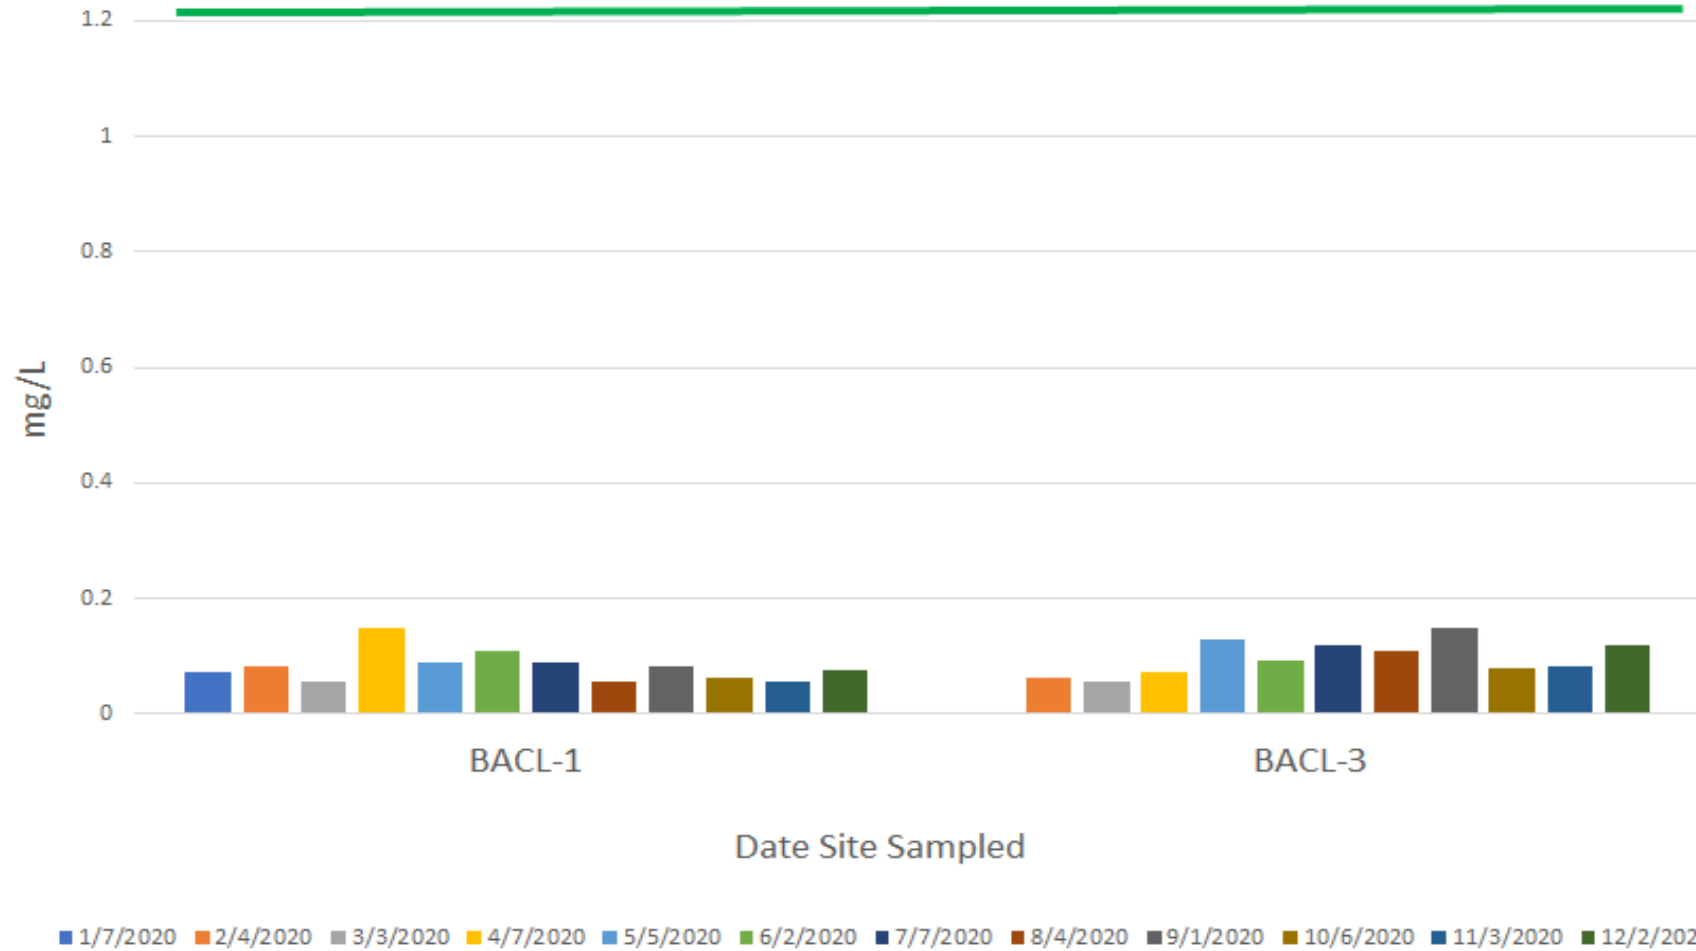
# MONTHLY PHOSPHORUS RESULTS

Collection Date	BACL-1	BACL-3
1/7/2020	0.074	ND
2/4/2020	0.084	0.062
3/3/2020	0.055	0.057
4/7/2020	0.15	0.072
5/5/2020	0.089	0.13
6/2/2020	0.11	0.092
7/7/2020	0.09	0.12
8/4/2020	0.056	0.11
9/1/2020	0.084	0.15
10/6/2020	0.062	0.078
11/3/2020	0.056	0.081
12/2/2020	0.077	0.12

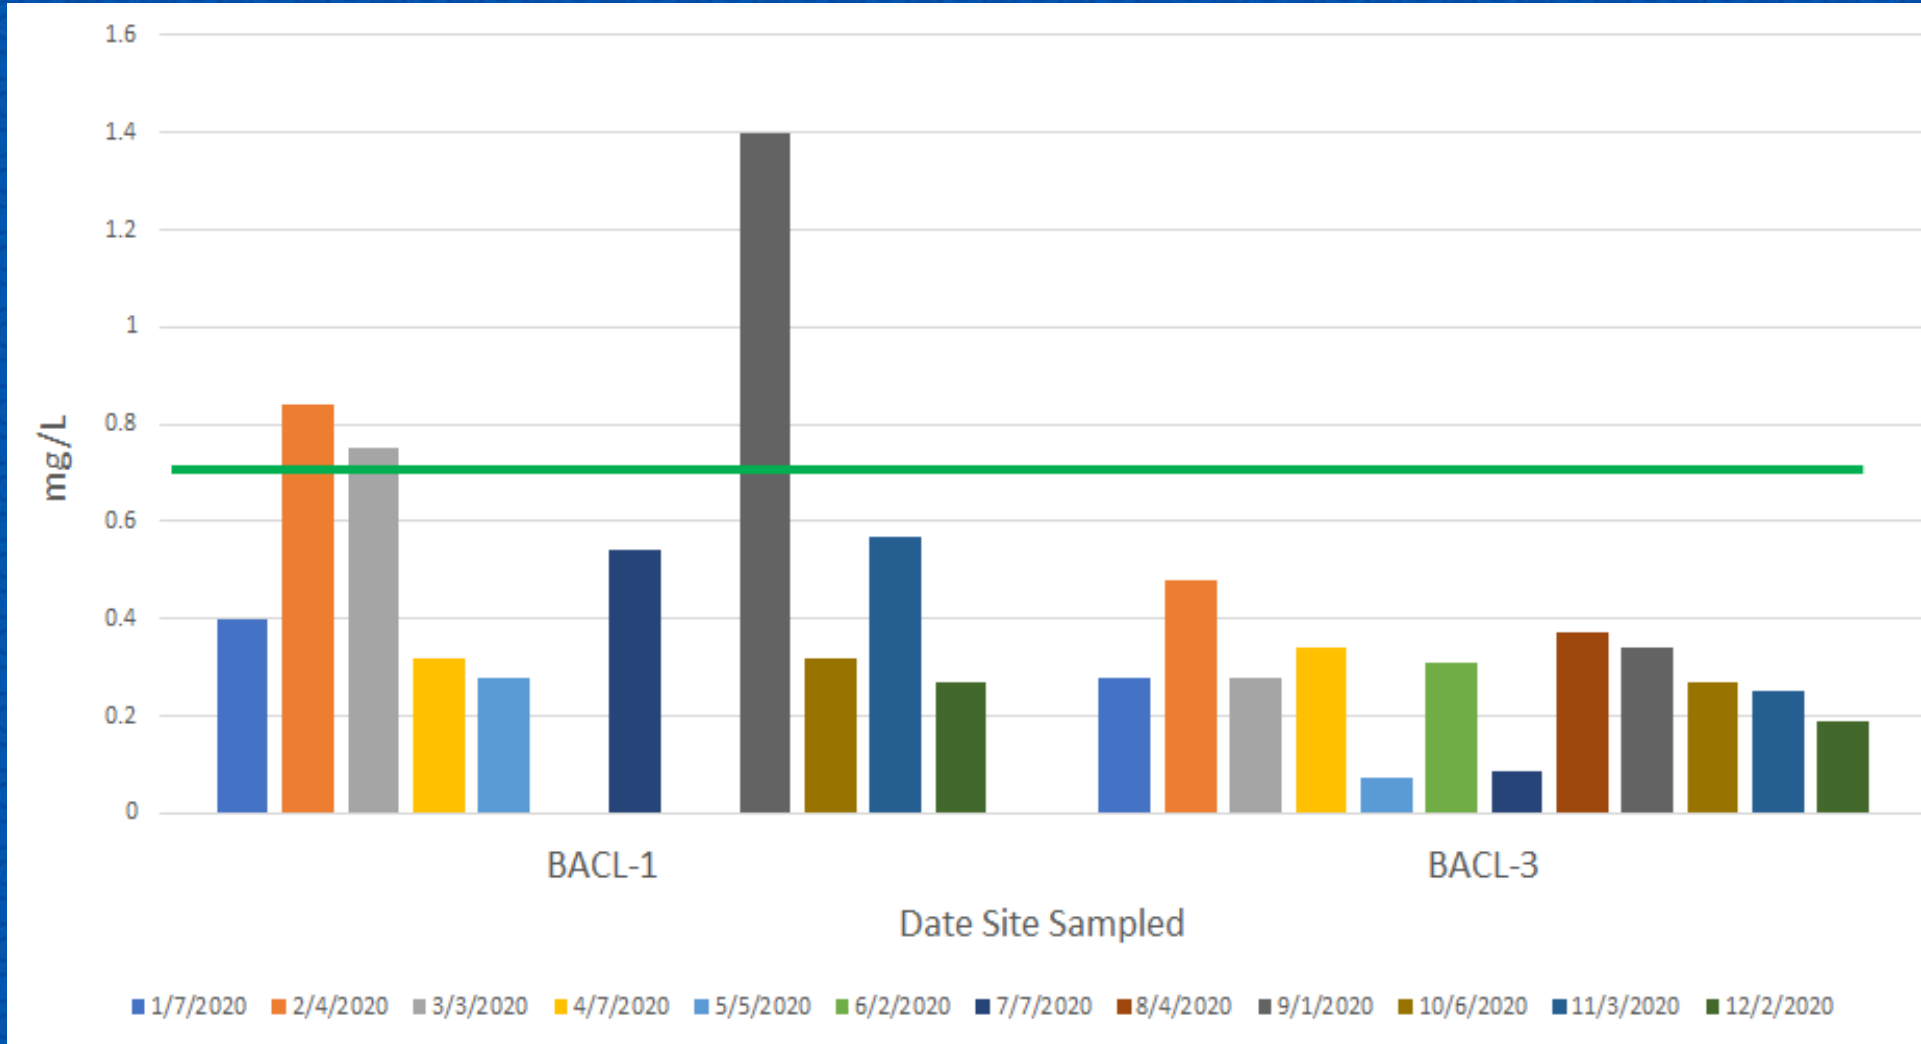
# Monthly Nitrogen Results

Collection Date	BACL-1	BACL-3
1/7/2020	0.4	0.28
2/4/2020	0.84	0.48
3/3/2020	0.75	0.28
4/7/2020	0.32	0.34
5/5/2020	0.28	0.071
6/2/2020	ND	0.31
7/7/2020	0.54	0.088
8/4/2020	ND	0.37
9/1/2020	1.4	0.34
10/6/2020	0.32	0.27
11/3/2020	0.57	0.25
12/2/2020	0.27	0.19

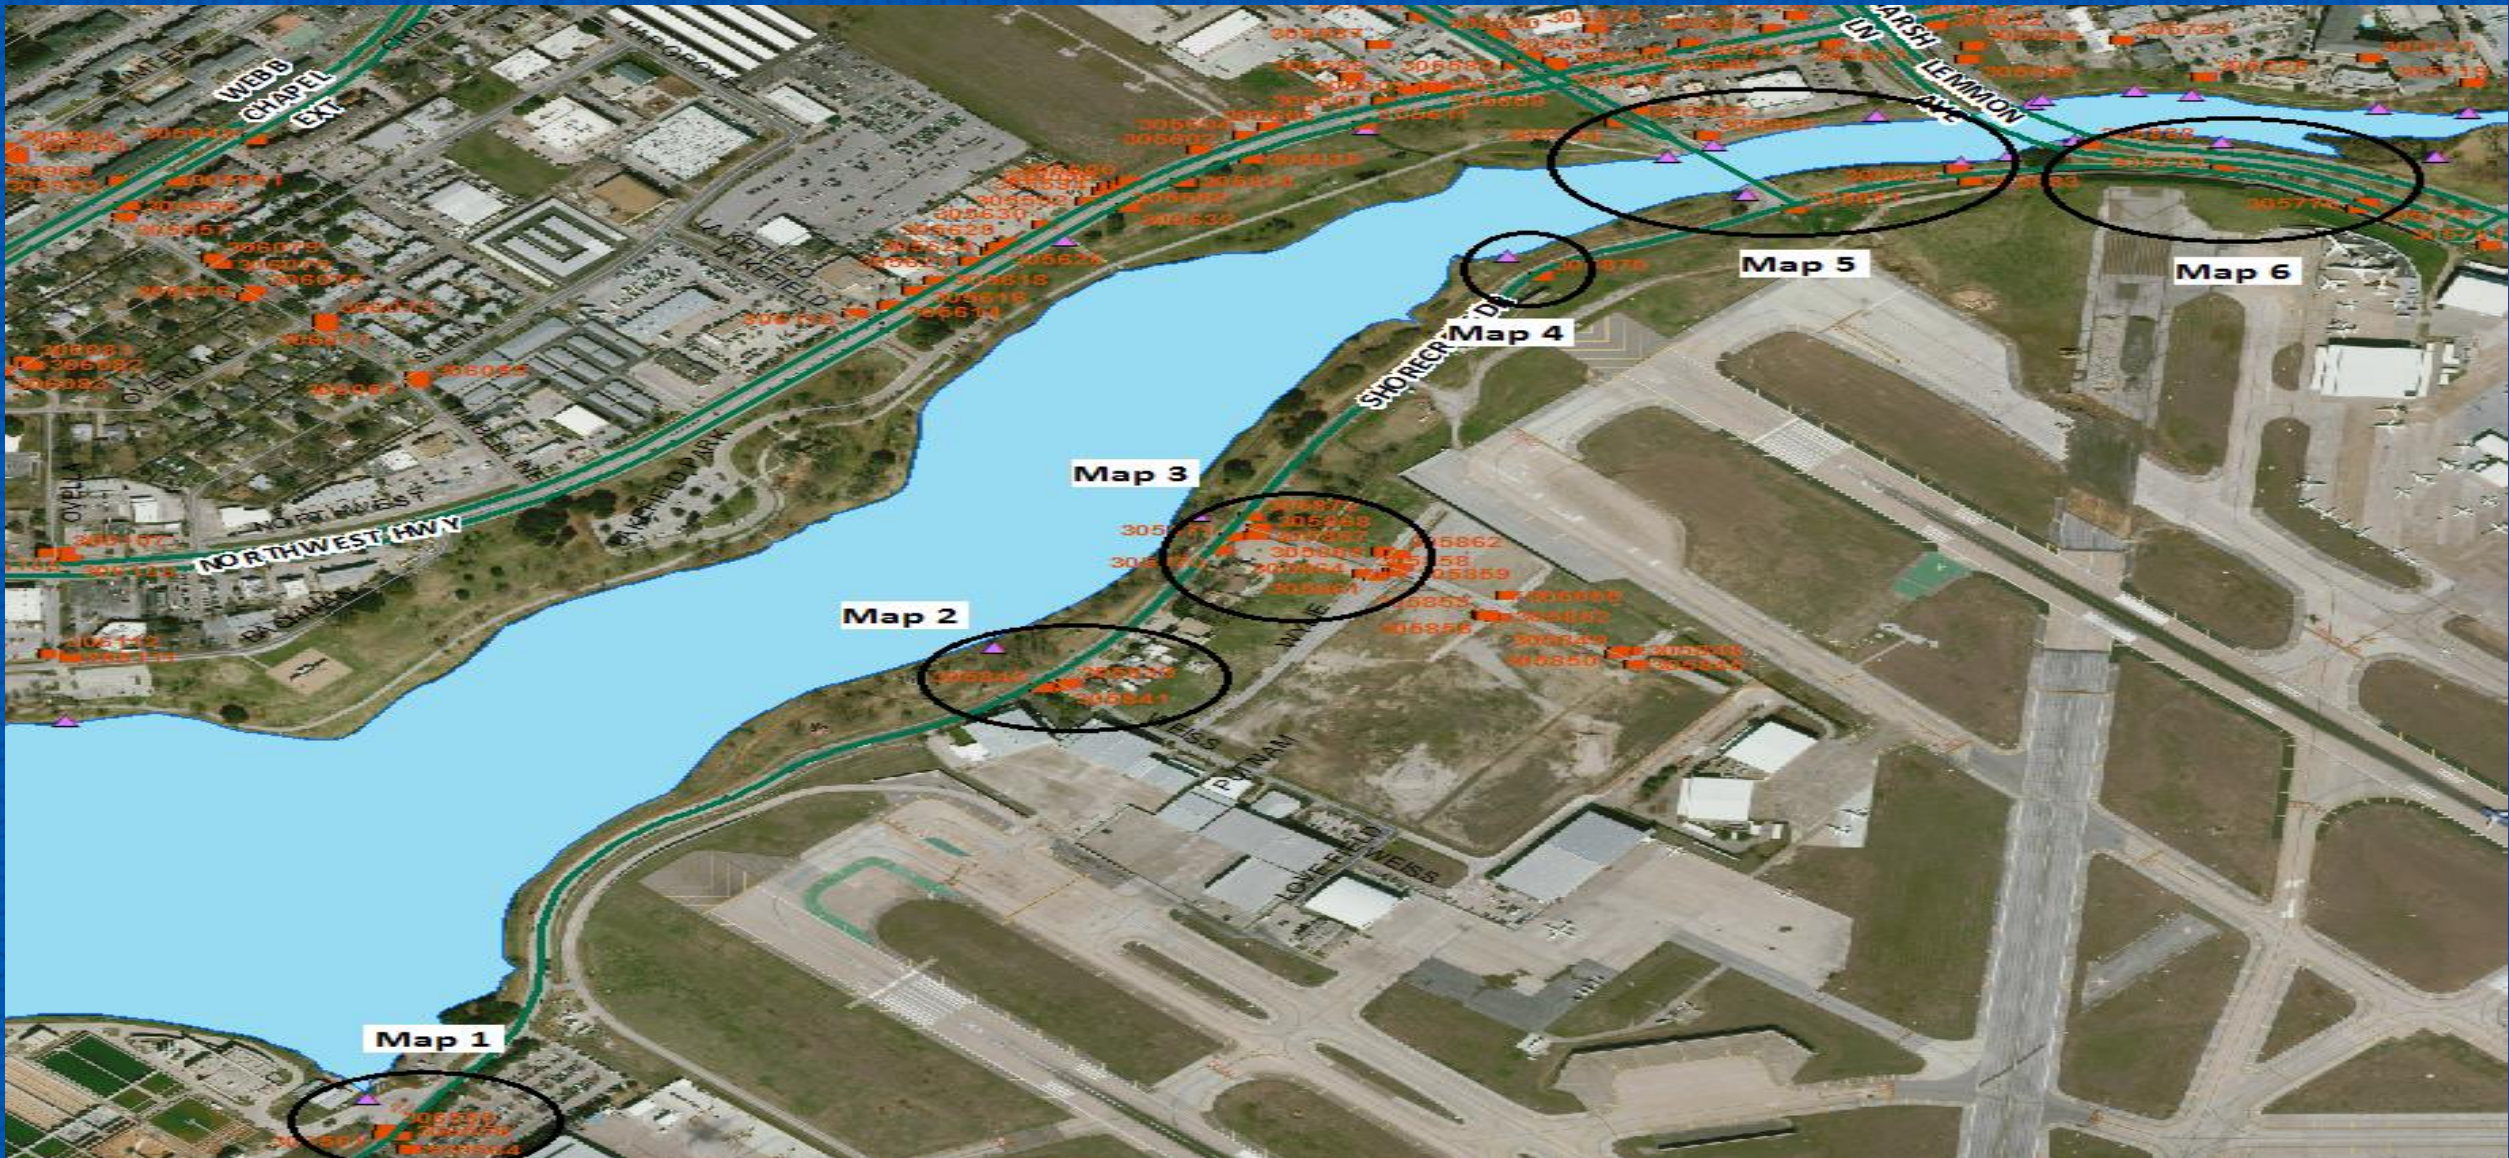
# BACHMAN LAKE INLETS AREA MAP

- The Neighborhood Drainage Service group is responsible for the removal of blockages on City-owned inlets, creeks/channels (except creeks and channels located in Parks), storm sewers, and responds to inclement weather emergencies such as snow/ice, windstorms and street flooding.

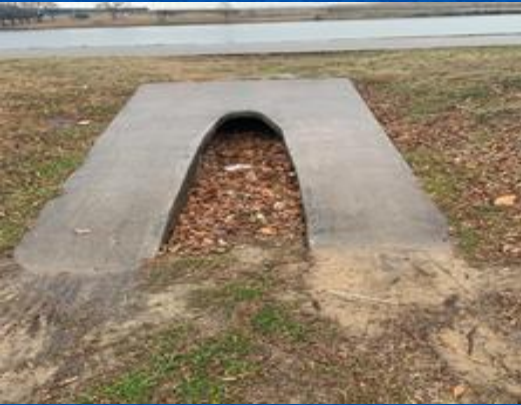
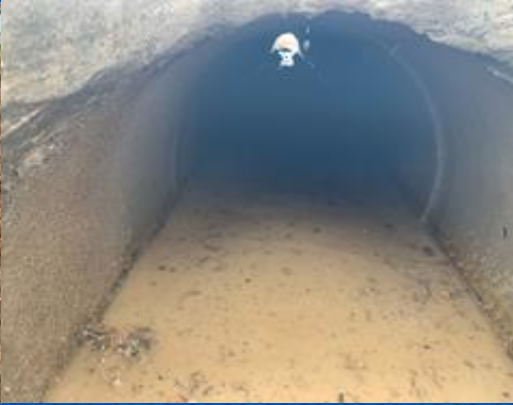
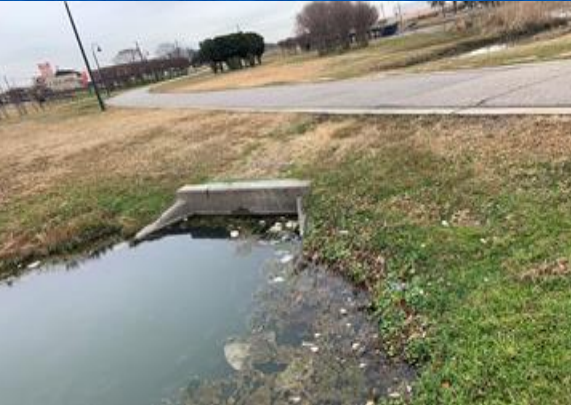
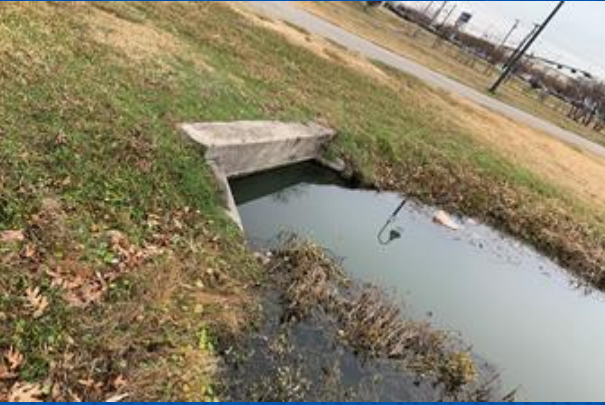
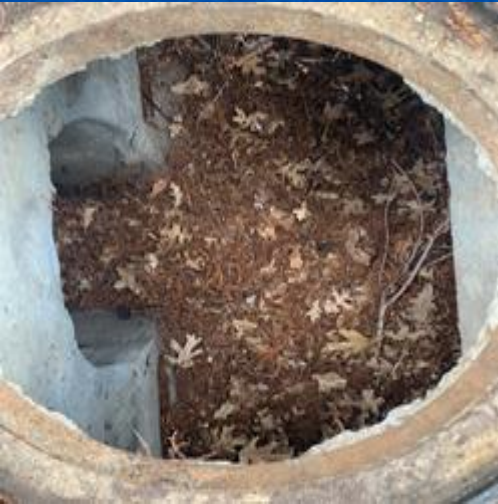
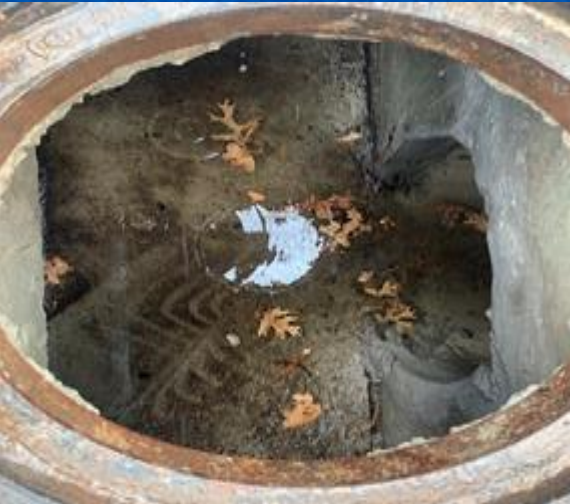
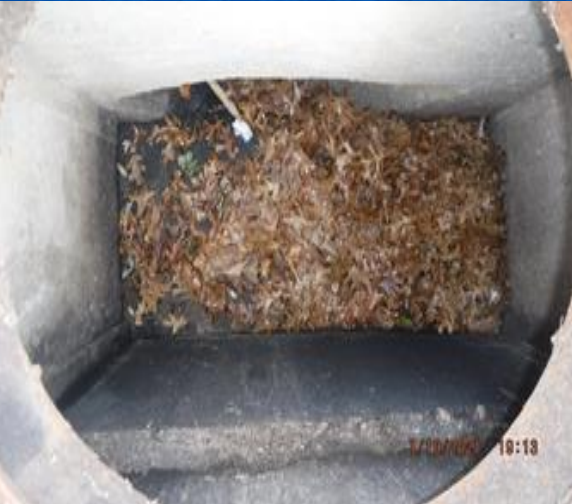
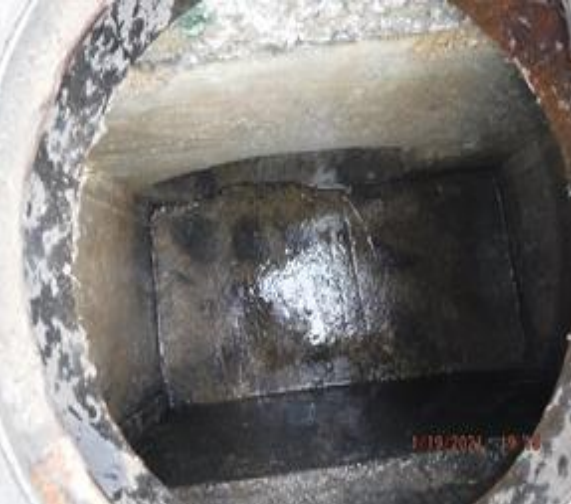
# BACHMAN LAKE CLEANED INLETS

Maintenance and Inspection of 25 inlets around Bachman Lake were performed the following dates:

No other deficiencies were found during our investigation.
